Phase I Environmental Site Assessment Report

Center Street - 12.72 Acres

**APNs 0277-022-67 and -68
Colton, California**

**Converse Project No. 17-16-148-01
July 17, 2017**

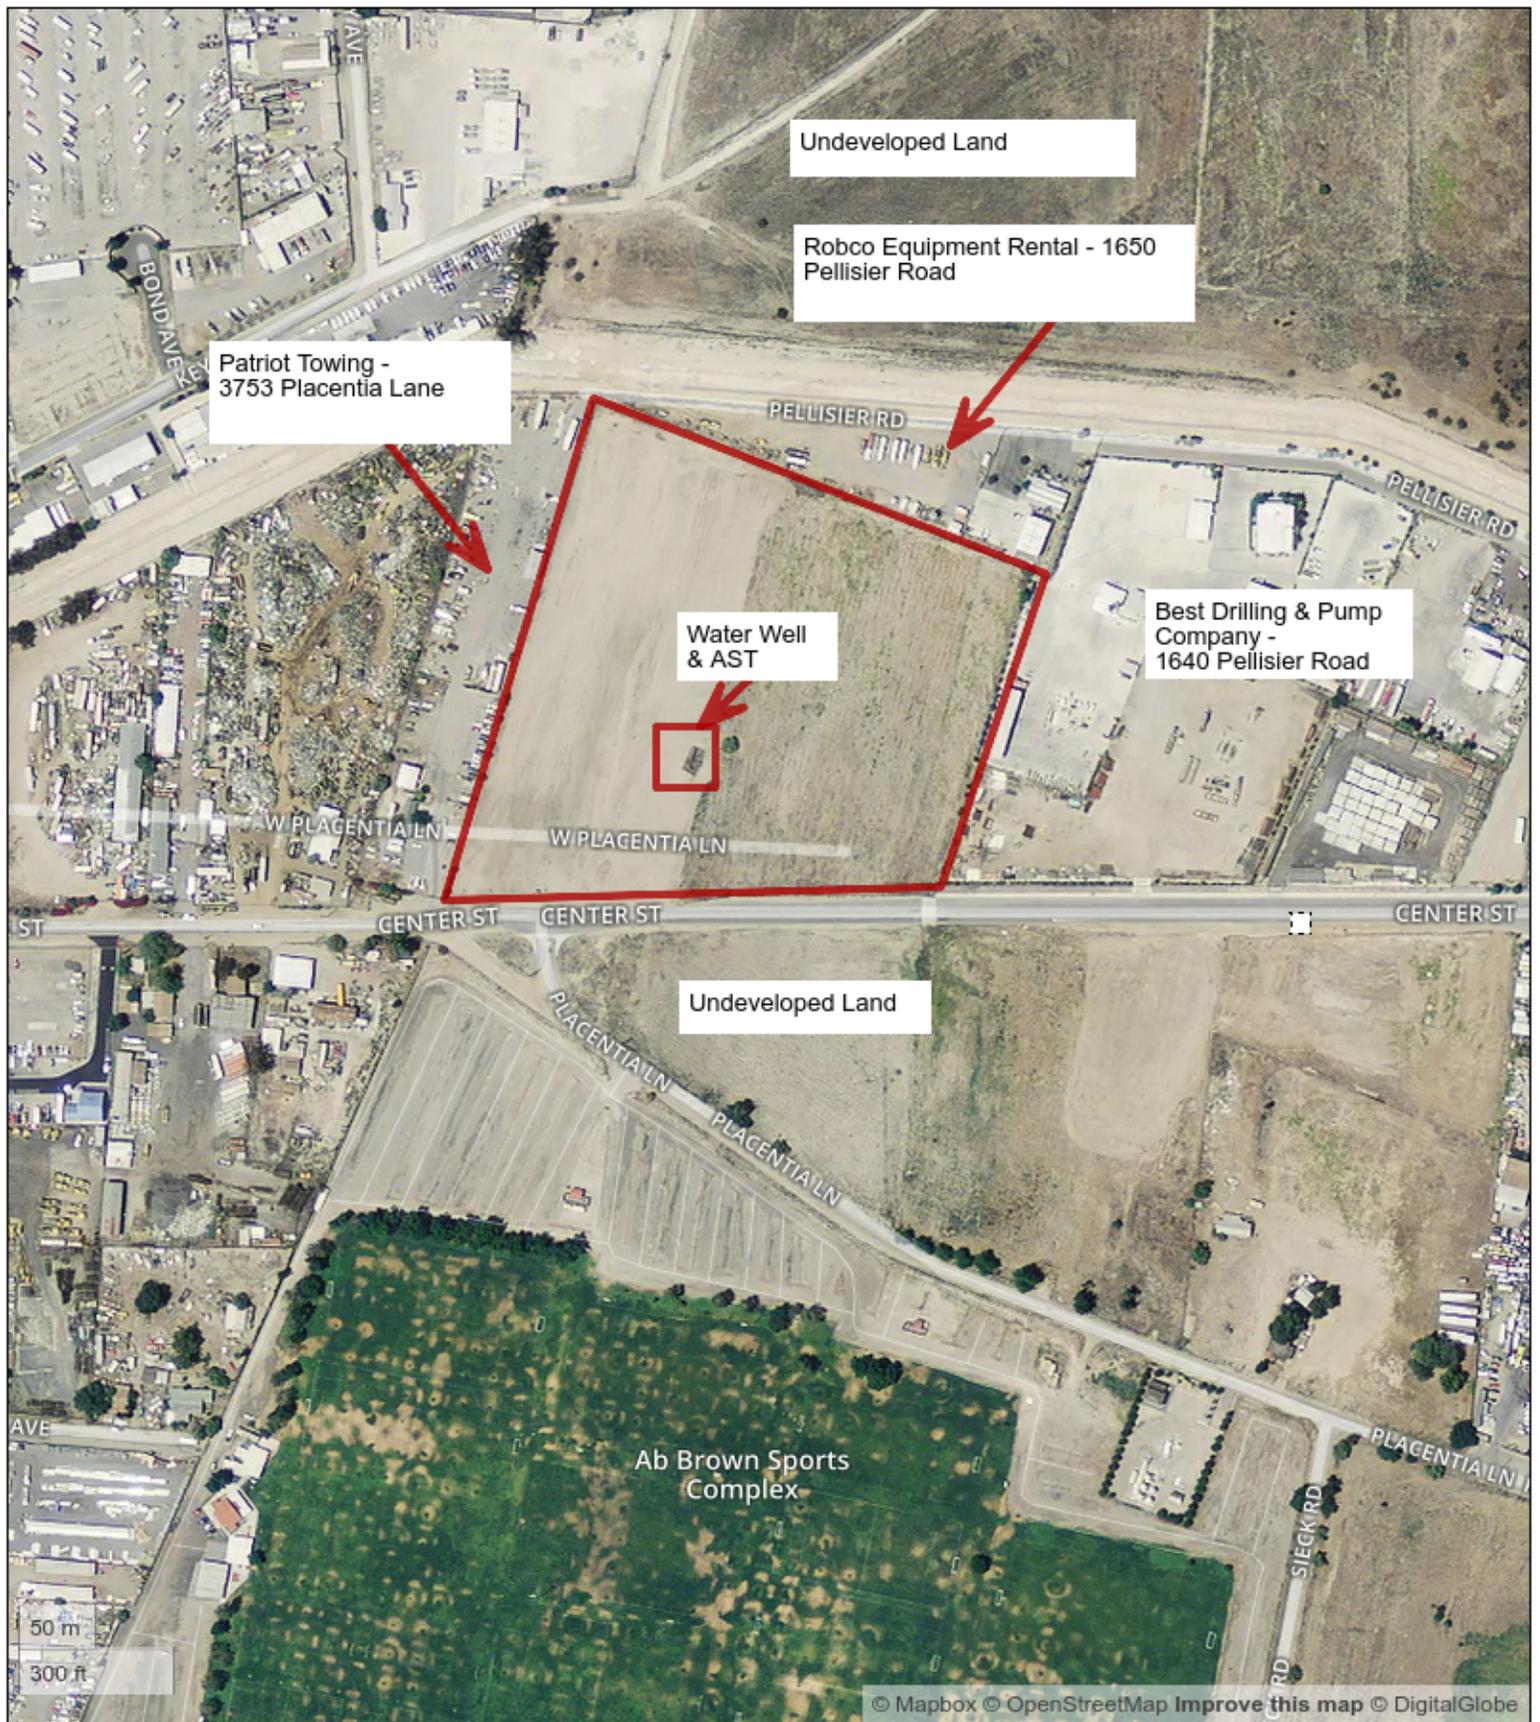
Figure 2

Property Map
 Center Street - 12.72 Acres
 Assessor Parcel Numbers (APNs) - 0277-022-67 and -68
 Colton, California

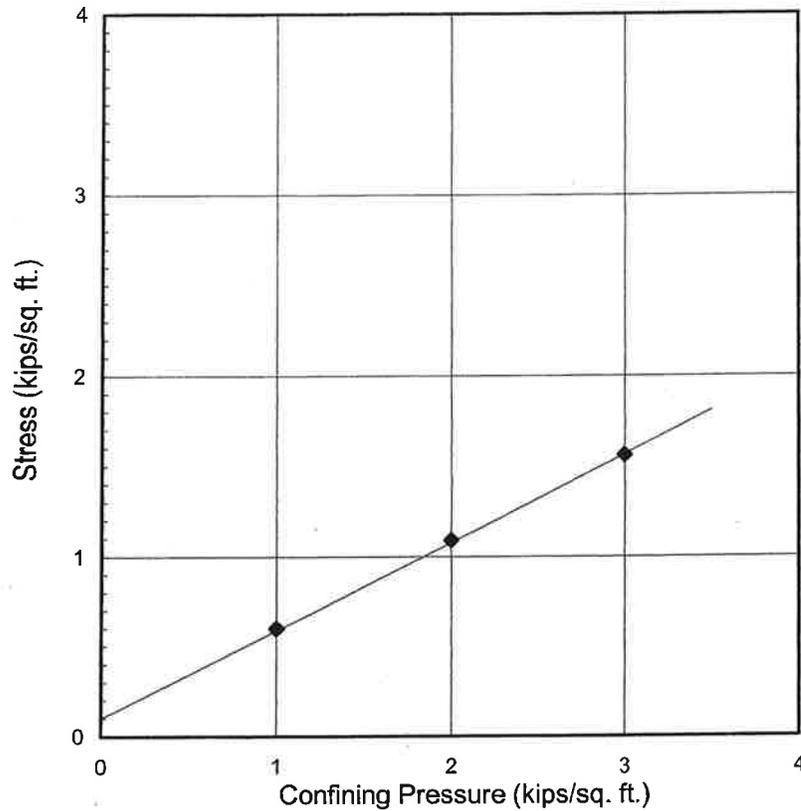
Boring No. 1 @ 5 Feet

SHEAR TEST RESULT

Sand samples were tested at saturated conditions.

The sample had a density of 105 lbs./cu.ft. and a moisture content of 6.4 %.

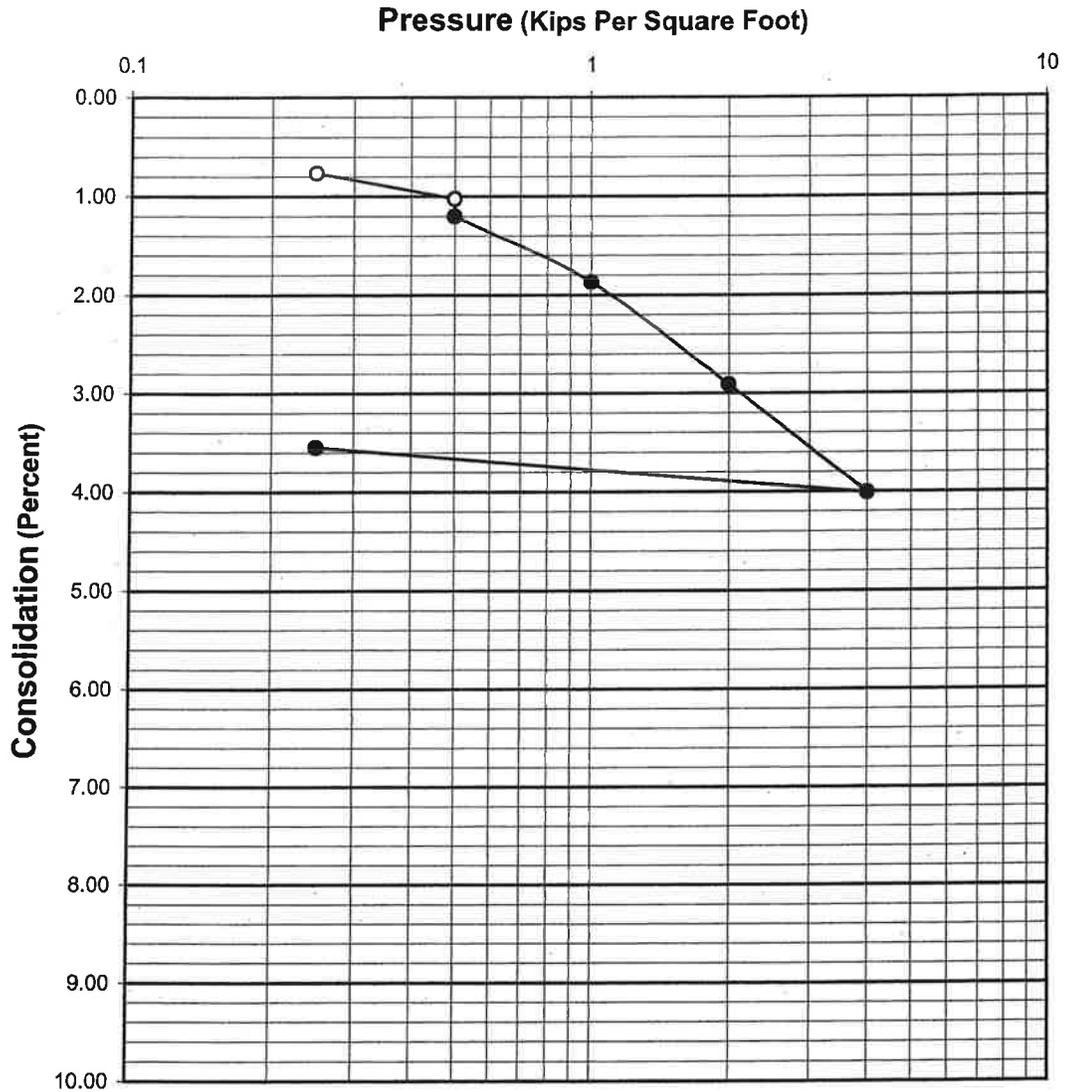
Boring No. 1 @ 5.0 Feet

CONSOLIDATION TEST RESULTS

○ Test Specimen at In-Situ Moisture

● Test Specimen Submerged

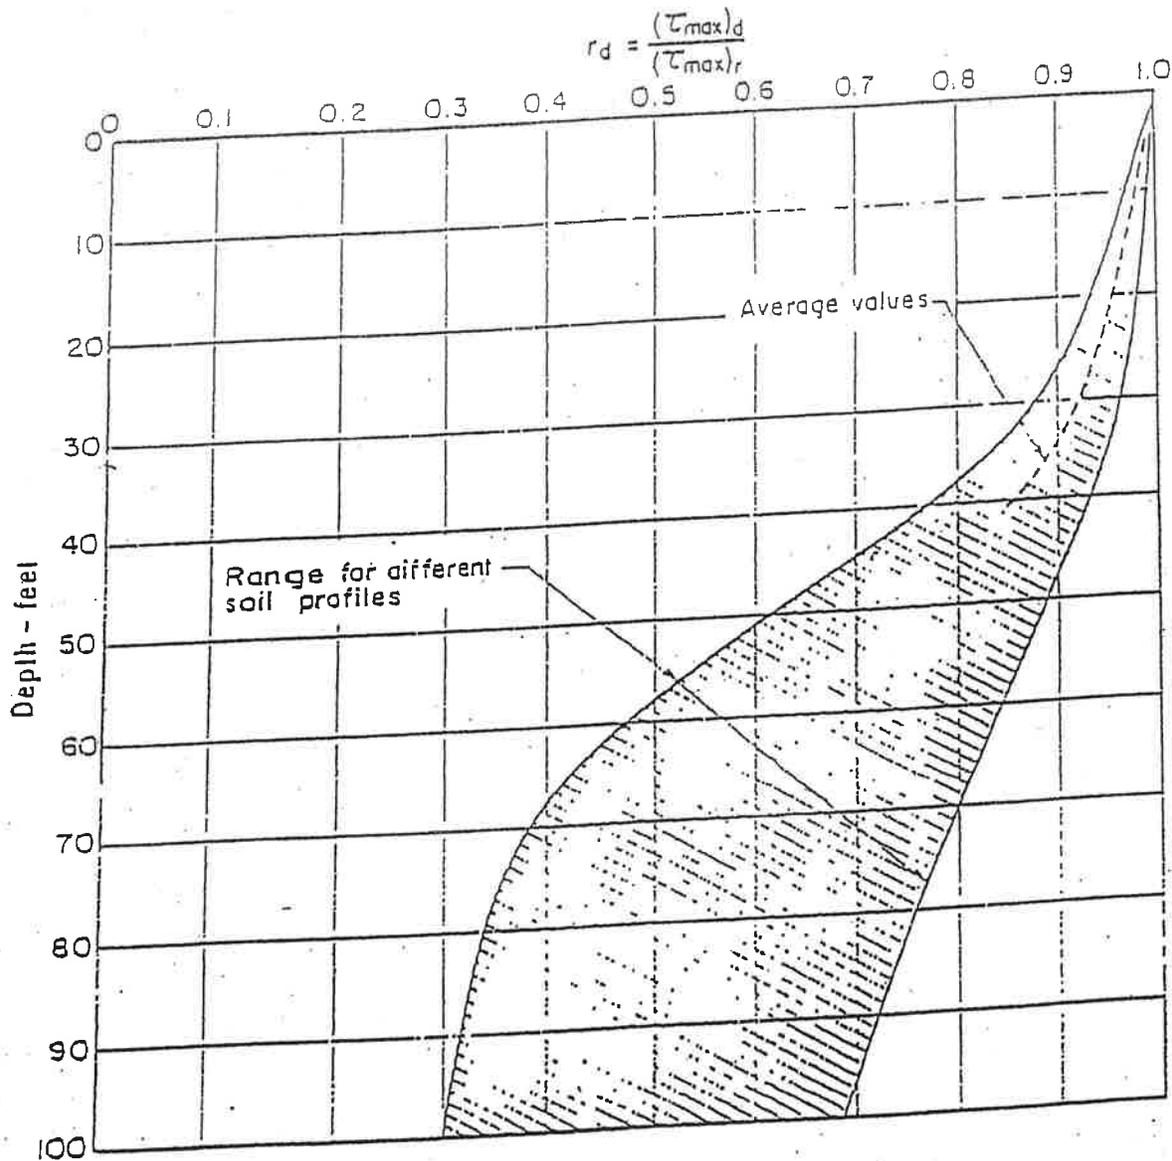
FIG. 1 - RANGE OF VALUES OF r_d FOR DIFFERENT SOIL PROFILES

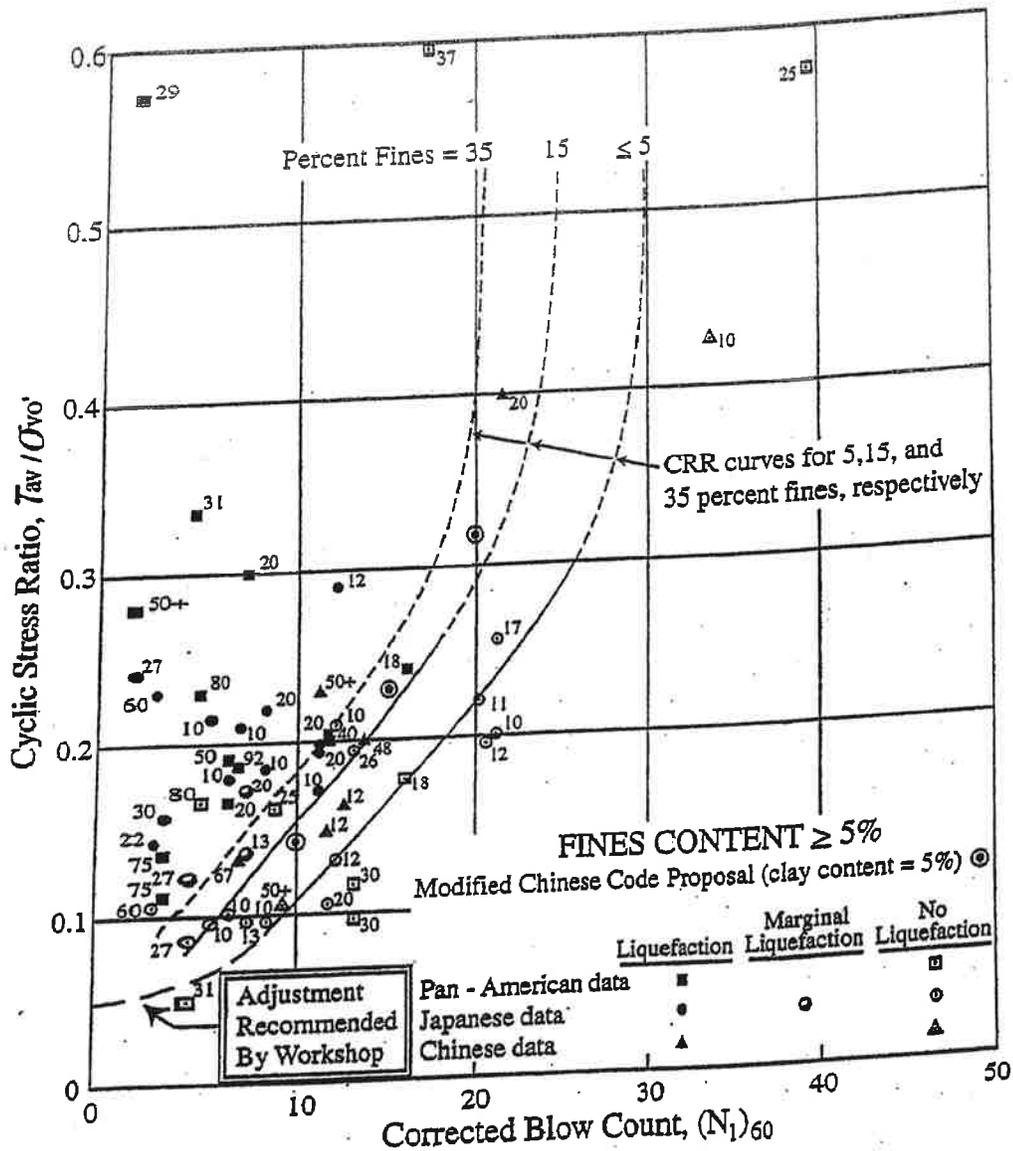
Figure 7.1. Simplified Base Curve Recommended for Determination of CRR from SPT Data for Moment Magnitude 7.5 Along with Empirical Liquefaction Data (after Youd and Idriss, 1997)

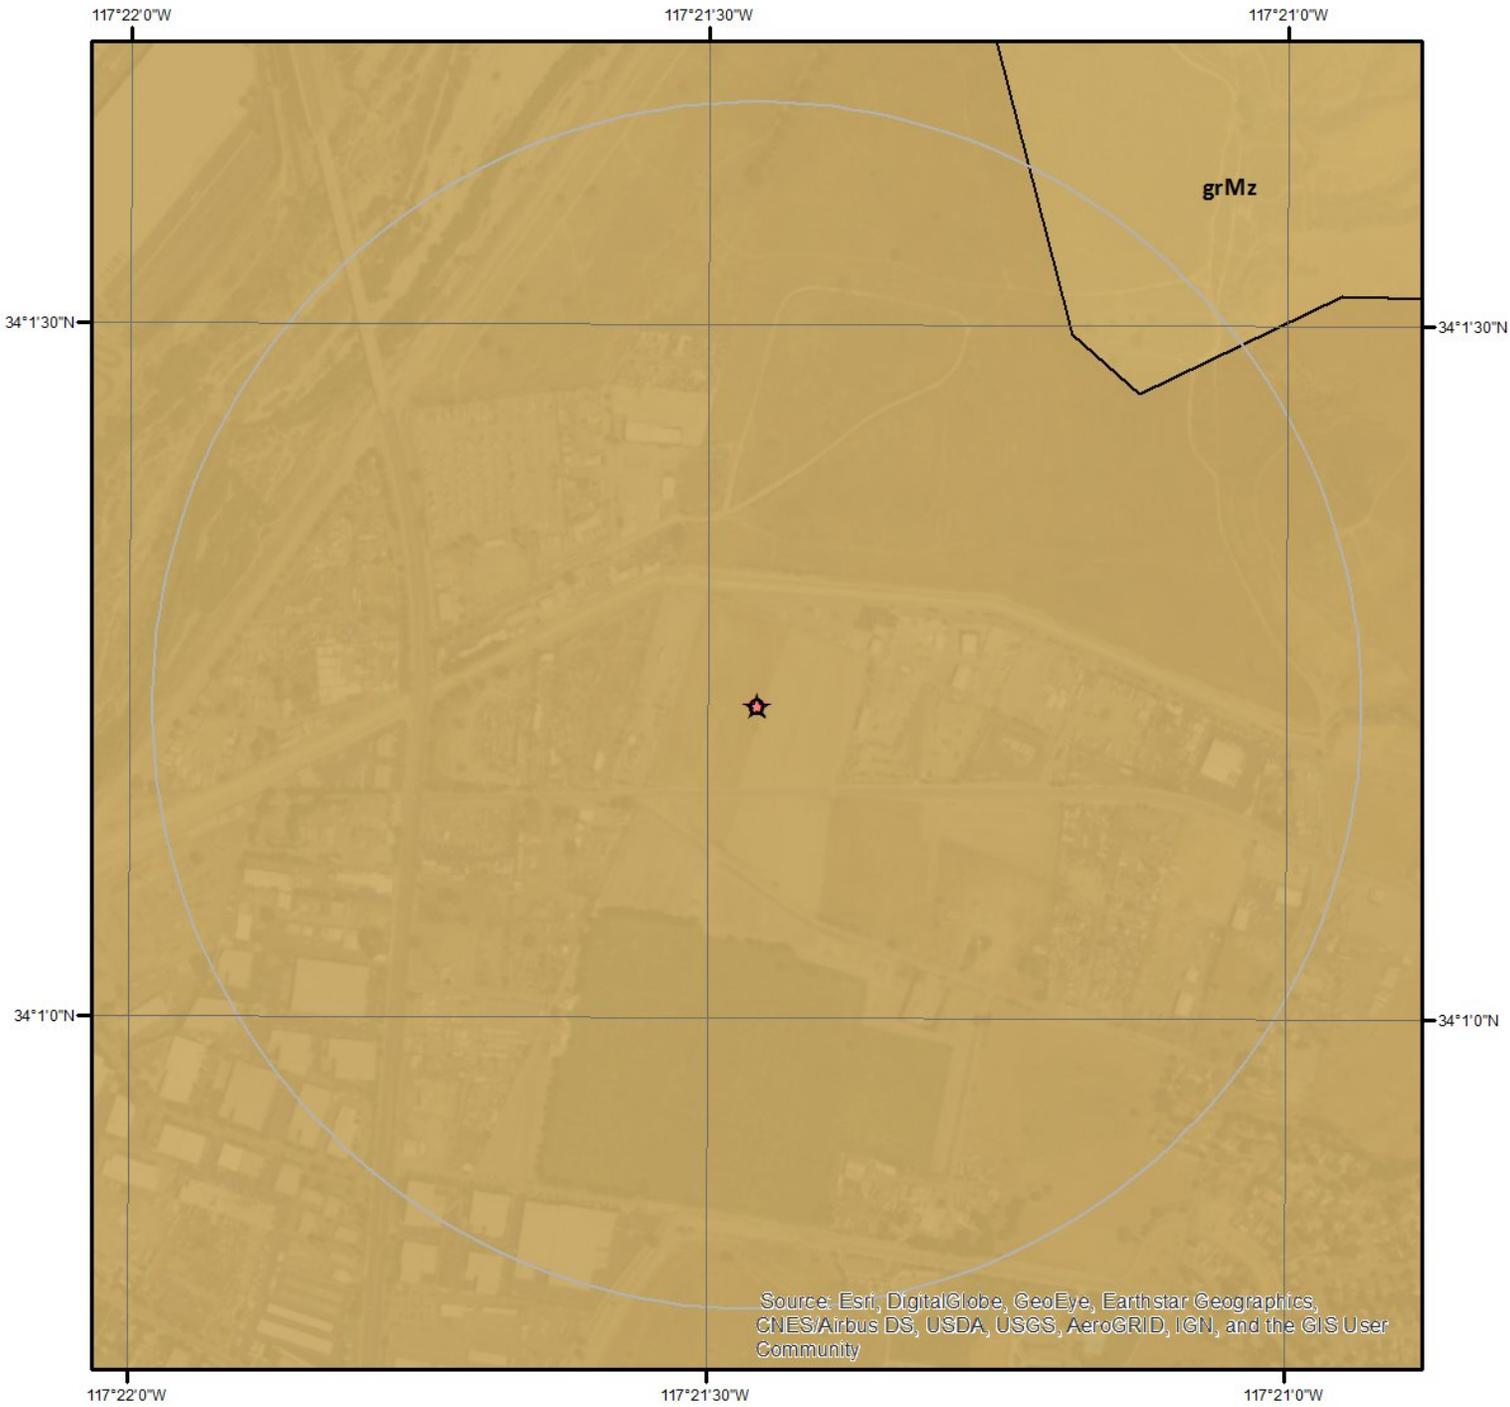
Geologic Units

This maps shows geologic units in the area. Please refer to the report for detailed descriptions.

Unit Name:	Quaternary alluvium and marine deposits
Unit Age:	Pliocene to Holocene
Primary Rock Type:	alluvium
Secondary Rock Type:	terrace
Unit Description:	Alluvium, lake, playa, and terrace deposits; unconsolidated and semi-consolidated. Mostly nonmarine, but includes marine deposits near the coast.

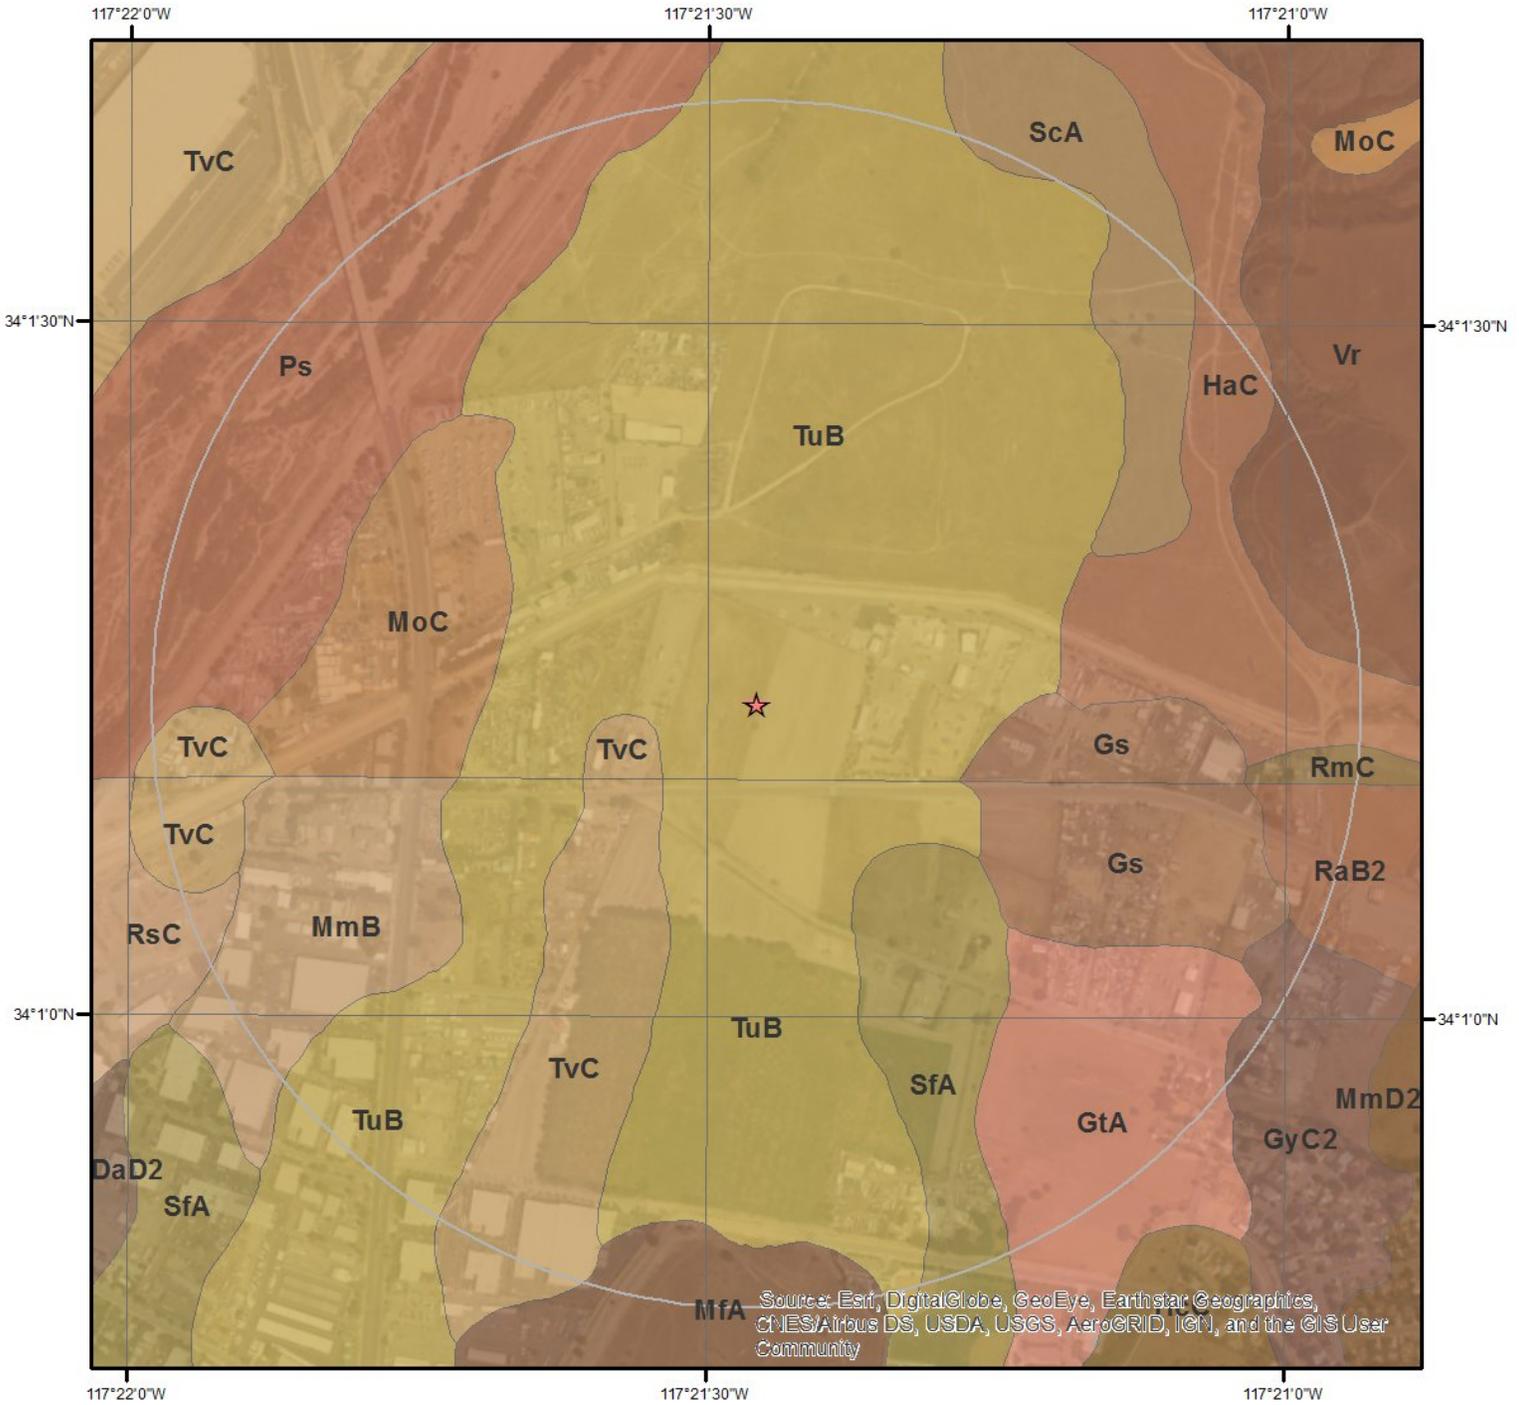
SSURGO Soils

Map Unit Name:	Vista-Rock outcrop complex
Bedrock Depth - Min:	0cm
Watertable Depth - Annual Min:	null
Drainage Class - Dominant:	Well drained
Hydrologic Group - Dominant:	B - Soils in this group have moderately low runoff potential when thoroughly wet. Water transmission through the soil is unimpeded.
Major components are printed below	
Vista(50%)	
horizon H1(0cm to 51cm)	Sandy loam
horizon H2(51cm to 97cm)	Coarse sandy loam
horizon H2(51cm to 97cm)	Sandy loam
horizon H3(97cm to 107cm)	Weathered bedrock
Rock outcrop(30%)	
horizon H1(0cm to 152cm)	Unweathered bedrock
