HISTORIC RESOURCES INVENTORY

1. Historic Name: None
2. Common or Current Name: None
3. Number & Street: 1200 North 9th Street  
City: COLTON Vicinity Only: Zip:92324 County (3-Letter Designator):SBR
4. Quad Map No.: 1074 UTM A: 11/470520/3770630 B: C: D:
5. Parcel No: 0161-111-29 Other:

1. Historic Name: None
2. Common or Current Name: None
3. Number & Street: 1211 North 9th Street  
City: COLTON Vicinity Only: Zip:92324 County (3-Letter Designator):SBR
4. Quad Map No.: 1074 UTM A: 11/470480/3770640 B: C: D:
5. Parcel No: 0161-101-16 Other:

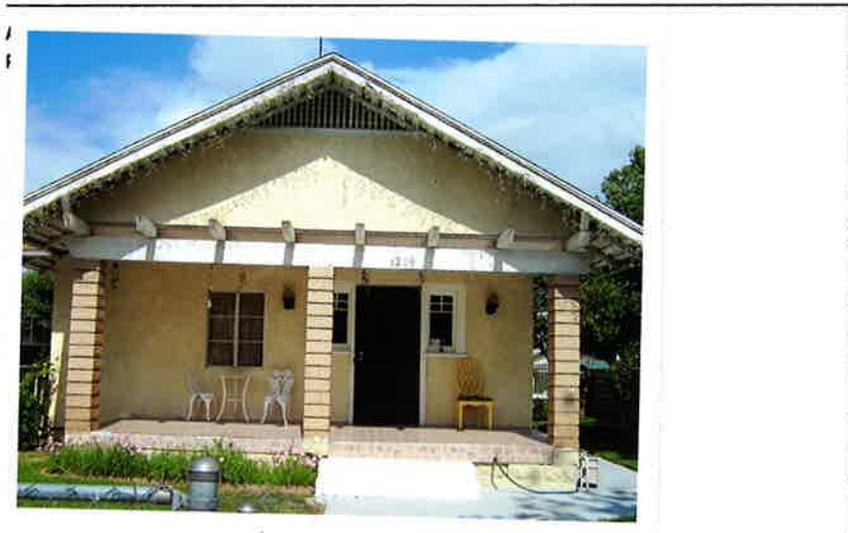
A single story, rectangular shaped building of wood construction on an east/west orientation in a Craftsman style. Roof is front hipped with a front gable extension, covered with composite shingles. Gable ends have lattic vent and shingle siding. Siding is wood clapboard. Windows are double hung. Two small rectangular multiple lite windows are located on either side of the front door. A front porch extends almost the entire length of the facade. Rafters extend from below the ceiling and are supported on a pair of cross beams. These beams are supported at the corners by two square full length posts, while two smaller paired posts frame the stairs. A low, wood ladder style balustrade has been extended upward with narrower wood strips, enclosing three-quarters of the porch opening. Foundation is cast stone. A separate garage is located to the rear, and is reached by a concrete driveway extending along the north side of the building. The front yard is surrounded in chain link fence and no landscaping is present.

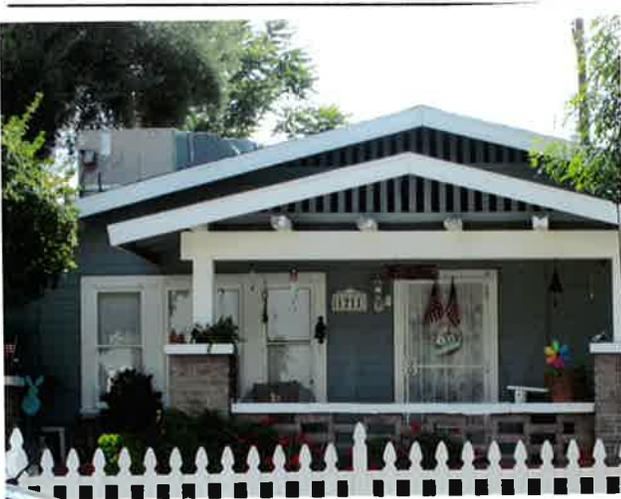
A single story, rectangular shaped building of wood construction on an east/west orientation in the Craftsman style. Roof is low front gable with composite shingles. A front gable extension covers the porch. Siding is clapboard. Windows are double hung. A grouping of three windows is located on wone side of the front door. Shutters have been added as decorative treatments around the front windows. Exposed rafters extend out from the front gable extension, supported by a massive heavy beam. Porch supports are square wood columns, resting on pedestals constructed of cast stone blocks. The balustrade consists of cast stone blocks set in a latticework pattern. Cast concrete steps are offset from the front door and extend out to the entry walk. Foundation appears to be poured concrete slabs that are stacked. Some landscaping is present.

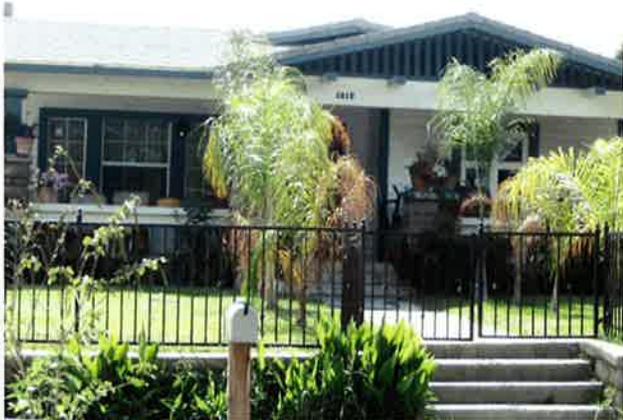
A single story, "C" shaped building of wood construction on an east/west orientation in the Craftsman style. Roof is low front gable with two side gables covering the wings, covered in composite shingles. An external chimney of cast stone is located on the south side. Siding is clapboard. Windows are double hung. An integral front veranda is present on this building. A small bay protrudes from the main mass into the veranda. This bay has one doorway, covered by a wood screen door. A second doorway opens from the main mass onto the veranda. A grouping of three double hung windows is located next to this second door. The veranda roof is supported by battered columns resting on piers of cast stone concrete. A single wood rail joins the piers together. Low, cast concrete steps extend forward from the building to the entry walk. Landscaping is mature.

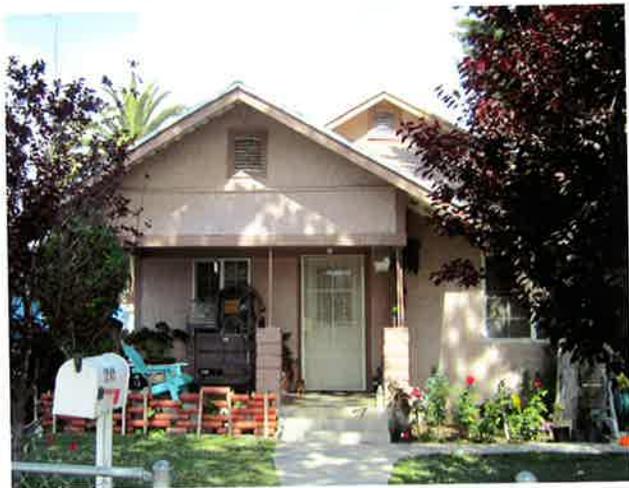
A single story, rectangular shaped building of wood construction on an east/west orientation in the Neoclassical style. Roof is hipped gable with composite shingles. Eaves are exposed. A lattice work attic vent is present in the hipped gable. Siding is wood clapboard above the window sill line and shiplap below. Windows are double hung and the front windows have queen-anne sashes in the upper sash. Front door is solid wood, with a wood framed screen. A separate gable extension covers the front entrance. The gable end has rough shingles and an attic vent with decorative trim. The porch supports are metal poles on concrete block bases, and are not original. Low concrete stairs extend out from the front towards the entryway, and to the side. A separate garage is located at the rear, and a concrete driveway extend along the north side of the building. Landscaping is minimal, and a chain link fence surrounds the entire front yard.

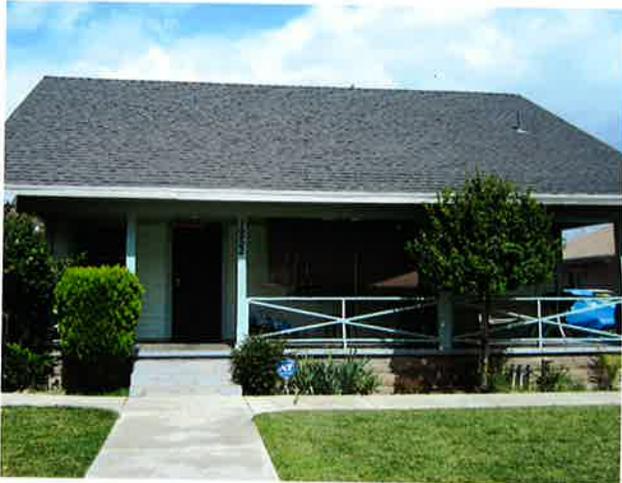
A single story rectangular shaped building of wood construction on an east/west orientation in the Craftsman style. Roof is side gable with composition shingles. A shed dormer, consisting of an slatwork attic vent and wood shingles is centrally located. Siding in the gable ends is wood shingles, while the main siding is wood clapboard. Three windows are present along the facade. Two windows consist of 15-over-one double hung windows located on either side of the front door. The third window appears to be double hung. A small bay window is located on the north side, and has a gable roof. It appears that an aluminum slider has been installed in the bay. A full length, integral veranda is present. Proch supports are solid wood posts with a cross style balustrade. Cast concrete steps extend away from the veranda to the entry walk. Foundation is cast stone block. A separate garage is present to the rear of the building, and a concrete driveway extends past the north side of the building. The landscaping is dominated by a large pine tree in the front yard.

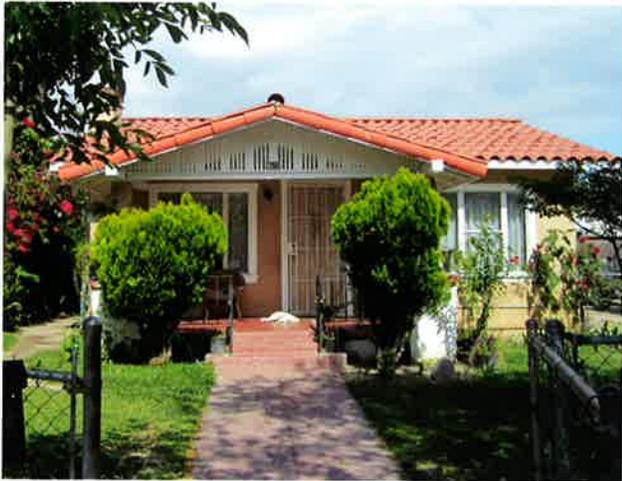
A single story, rectangular shaped building of wood construction on an east/west orientation in the Craftsman style. Roof is low side gable with composite shingles. A front gable extension covers the porch. An external chimney, of stucco is located on the north side. Siding is wood shiplap. Windows are double hung. One window is covered by an aluminum awning. The porch roof is supported by two battered wood columns resting on stuccoed piers. Foundation appears to be concrete. A separate garage is located to the rear, and a concrete drive way with grass center strip extends past the building on the south. Two large bushes hide the front porch, and the balance of landscaping is simple. A chain link fence surrounds the front yard.

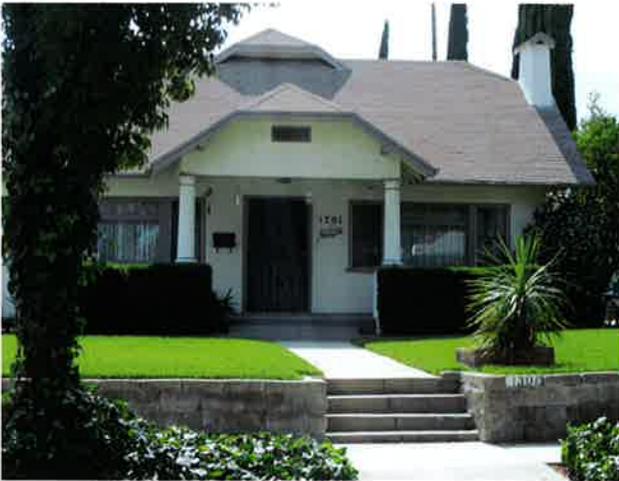
A single story "C" shaped building of wood and stucco construction on an east/west orientation in the Colonial Revival style. The facade is symmetrical. Roof is hipped gable with composition shingles. Two small gables extend out over the two side extensions, while a hipped gable extends out over the front porch. A small hipped gable dormer is located high up on the roof line, near the ridge pole. An external, stuccoed chimney is located on the north wall. Siding is smooth stucco. Two windows are located on either side of the central front door. This windows consist of two three over one double hung windows located on either side of a large fixed sash with six-lite transom. The front door is unknown. A wide patio extends out beyond either side of the porch roof. The porch roof is supported by two classical columns resting on simple stucco pedestals. Cast concrete steps extend out forward, while two sets of concrete steps extend out on either side of the patio, parallel to the building. Some landscape is present.

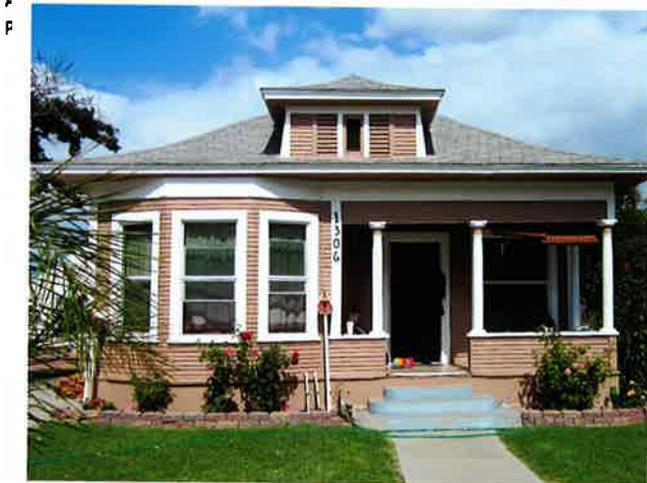
A single story, rectangular shaped building of wood construction on an east/west orientation in the Neoclassical style. Roof is hipped with composite shingles. Hipped dormers are located on both the front and side, consisting of two slatwork attic vents located on either side of a rectangular window. Eaves are boxed. Siding is wood shiplap. Windows are double hung. A bay window protrudes forward on the building as does a second bay on the south wall. A partial, integrated front veranda is present. The window located within the veranda has a fixed sash with transome in a diamond lite pattern. Veranda roof supports are classical columns resting on a solid balustrade covered in shiplap. Cast cement steps extend forward towards the entry walk. Some landscaping is present.

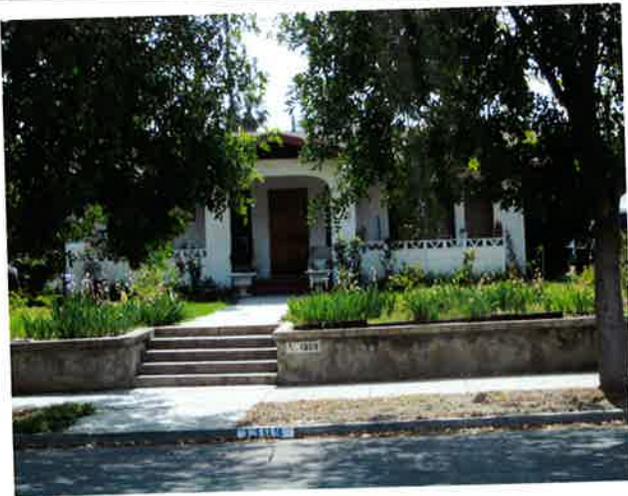
A single story, rectangular shaped building of tile and stucco construction on an east/west orientation with some Craftsman details. Roof is side gable with composition shingles. Siding is stucco. Windows are single sash casement with narrow glass panes surrounding the main rectangle of glass. A separate front porch roof is present. This roof is low front gable with verticle slatwork attic vent. It is stucco, with a rectangular opening that has been rounded in the corners. This same treatment extends back to join the addition to the main building. A patio extends on either side of the porch roof, and is enclosed by a concrete block wall. A low cast concrete step extends forward, and a second flight of steps extends to the side. A concrete driveway extends past the north side of the building. Landscaping is minimal, and there is a concrete retaining wall along the front sidewalk.

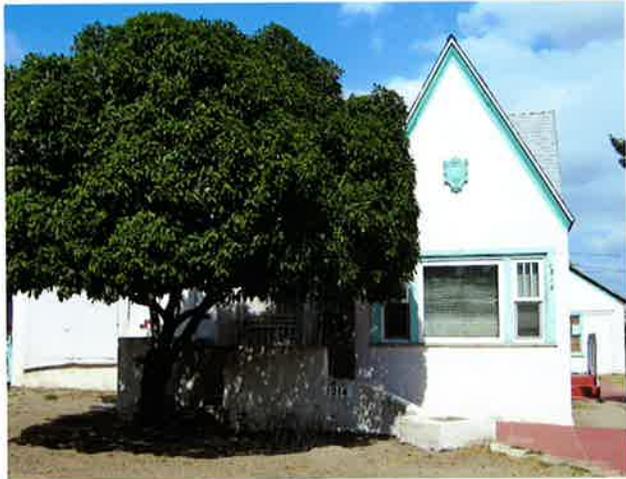
A single story, irregular shaped building of wood and stucco construction on an east/west orientation, with English Tudor style. Roof is high gable with opposed front and rear gables covering the wings. Roofing is composite shingles. An external stucco chimney is prominently located on the facade and has a small recessed arch indent and artificial brick details added. Siding is rough stucco. A cast plaster detail is inset on the front gable. Windows are double hung. The front windows consist of a grouping of two three-over-one double hung windows on either side of a fixed sash, and a large single sash window with arched wood moldings. Front door appears to be multiple glass panels set in a wood frame. The main facade extends out to a separate wall with an arched opening and gate passage to the rear of the building. A small halfwall surrounds the front entrance courtyard and ends in a low sweeping curved wall that follows the entrance walkway. A separate side entrance is located on the south wall towards the rear. A separate garage is located at the rear, and a concrete driveway extends past the house. Landscaping is simple.

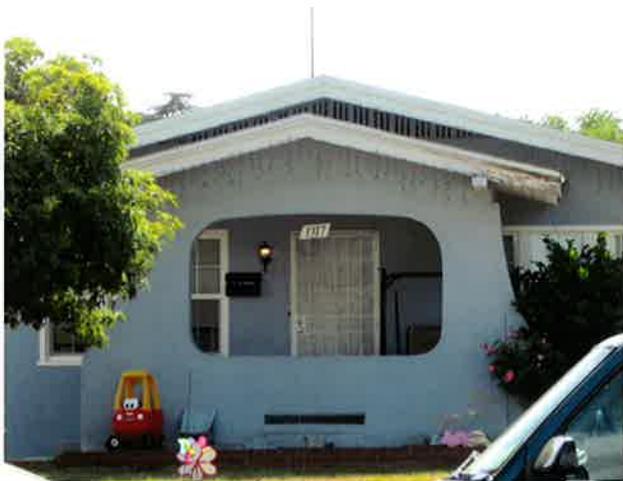
A single story, rectangular shaped building of wood and stucco construction on an east/west orientation with Craftsman influence. Facade is symmetrical. Roof is front gable with composite shingles and a front gable addition covers the front porch. An external chimney covered in stucco is located on the south wall. Siding is stucco. Windows are eight-lite casements that open inward. The front porch roof support consists of a solid wall with a large rectangular opening with curved corners. This support is stucco. Steps extend to one side away from the porch and towards the concrete driveway. A separate garage is located to the rear of the building. Landscaping is mature, and dominated by a large tree in the front yard.

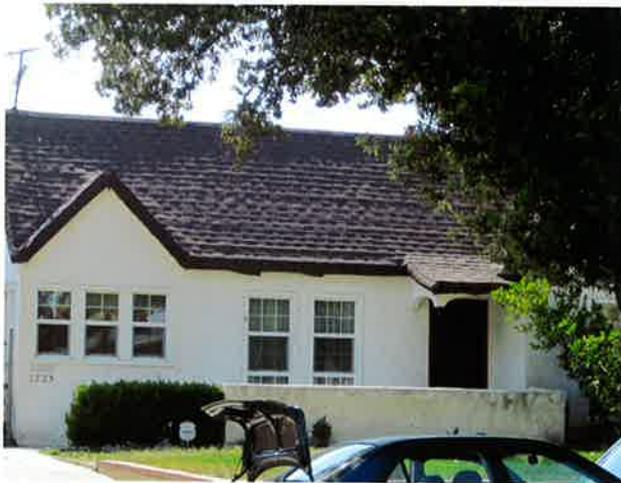
A single story, irregular shaped building of wood and stucco construction on an east/west orientation in the English Tudor style. Roof is side gable, with lower front gables, covered in composite shingles that are rolled under at the eaves to in a false thatch. A short wing protrudes forward. An arched attic vent is located in the front gable. Siding is textured stucco. Windows are double hung. A group of three four-over-one double hung windows are located on the front wall. A pair of multiple lite casement windows are located adjacent to the front door, while a pair of ten-lite casement windows are located in the forward wing. An extension of the roof covers the front entrance. Eaves under this roof extension have an arch, ending at the corner of the extension in a decorative ball. No porch roof supports are present. A half-wall encloses the front courtyard, with the walkway extending to the side. A separate, flat roofed garage is located to the rear, passing through a covered porte cochere that appears to have been added at a later date. The concrete driveway extends along the south edge of the building and has a grass center strip. A low retaining wall is located along the sidewalk and some landscaping is present.

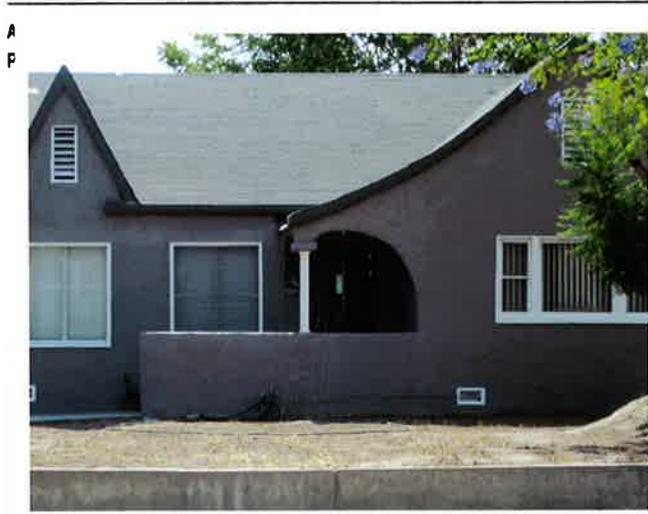
A single story, rectangular shaped building of wood and stucco construction on an east/west alignment in the English Tudor style. Roof is side gable, with lower high front gables, covered in composite shingles. Shingles are wrapped over the eaves in a false thatch. An external brick chimney is located on the south wall. Siding is textured stucco in a waddle and dab pattern. A window grouping, consisting of two double hung windows on either side of a fixed sash is located in the forward gable extension. An aluminum awning and decorative shutters complete this window group. Balance of windows are double hung. The roof extends out over the porch area and is joined to the wall through a stuccoed arch support. A half-wall encloses the courtyard area. Steps extend sideways towards the driveway. An aluminum awning has been installed over the courtyard. A separate rear garage is present, and a concrete driveway extends along the south side of the building. A low, concrete retaining wall is along the sidewalk. The landscaping is dominated by a large tree in the front yard.

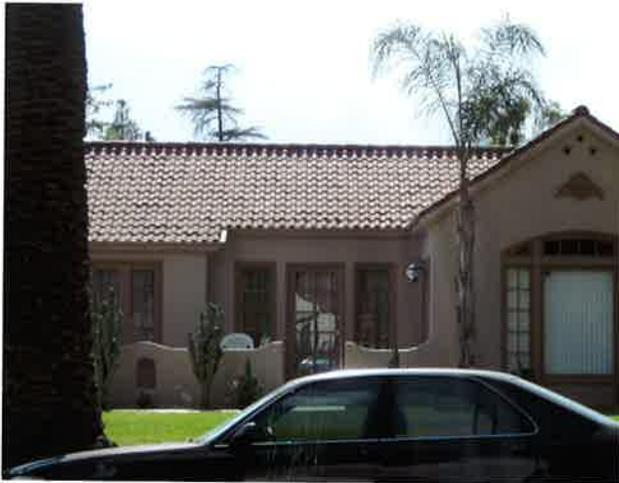
A single story, "EL" shaped building of wood and stucco construction on an east/west orientation in the Spanish Revival style. Roof is side gable with a front gable wing, covered in clay tile. An external chimney is located on the north wall. Siding is smooth stucco and there are buttresses located on the corners of the front wing. Eaves are flared and stuccoed. Decorative cast plaster details are attached to the gable end. Windows appear to be long, multi-pane casements that extend to the floor. An arched window, consisting of a fixed sash surrounded by two twelve-lite casement windows and four-lite transom filling the arch. A stuccoed half wall with decorative curves encloses the courtyard. A small arched opening within this wall holds a cast-in planter. A false porte-cochere bridges the driveway, with a shed type tile roof. Wrought iron details are attached to the courtyard wall. Some landscaping is present.

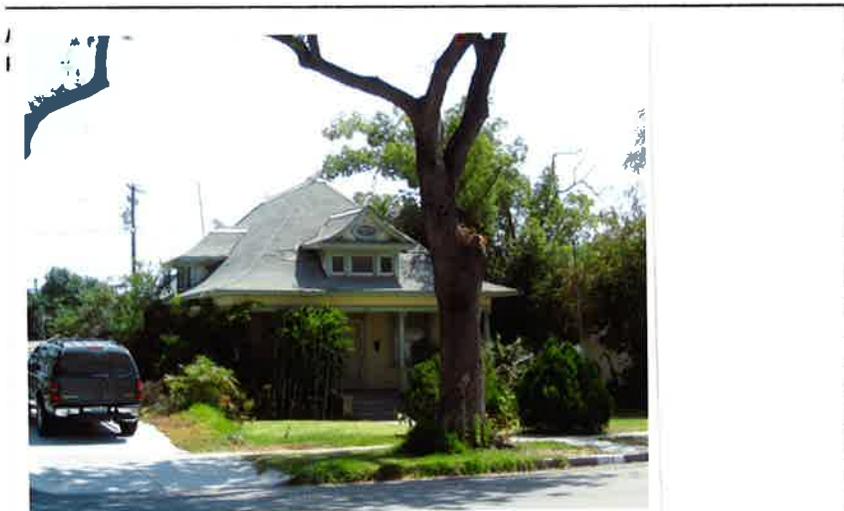
A single story, rectangular shaped building of wood construction in the Neoclassical style. Roof is bellcast hip with composite shingles. Bellcast hip dormers are located on either side and a front gable dormer is present on the front of the building. An bull's eye attic vent is located within the gable. Windows in the dormer are amber glass. Eaves are boxed with a wide frieze. Siding is milled shiplap. Side windows are double hung. A bay window projects out on the west side of the building. Front windows are fixed sash with eight lite transome located on either side of the central front door. Front door is multi-lite glass and wood. An integrated front porch extends along the entire facade. The porch roof is supported by four classical columns with ionic capitals, resting on the wood balustrade. The balustrade is simple. Foundation appears to be cast stone. Concrete steps extend out, surrounded by a cast concrete rail, with indented panels. Landscaping is simple.

This particular structure is significant under the Architecture and Construction theme. It is an excellent example of the Neoclassical style, with its classical ionic columns, central dormer and symmetrical facade. This building was built after February 1907, possibly by F. Janette Wiley who owned the property from 1906 through 1918. Sanborn maps for February 1907 show a foundation being laid out on this site. It was then sold to Jessie Leola Willey. It is not known if the spelling on Willey is an aberration of Wiley or if these two individuals are related. Willey owned the property until 1926 when it solde to F. Janette Swartz. It appears that Swartz is also F. Janette Wiley, due to the same first initial and middle name. Swartz owned the property until 1945 when it sold to Edna B. Windas who owned it through 1947.

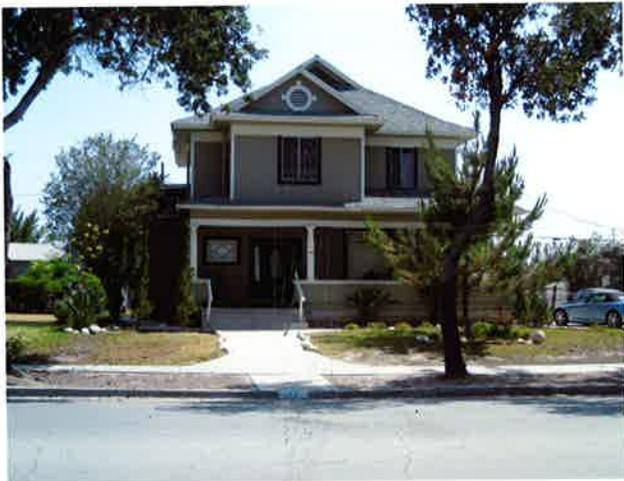
A two story, rectangular shaped building of wood construction in the Colonial Revival style. Roof is hipped gablet, with lower cross gables, covered in composite shingles. Front and side gables have bull's eye attic vents. A second front gable has a slatwork attic vent. Siding is shiplap. Windows on the second story have been replaced with aluminum sliders, and it appears that the second story has been slightly altered. Side windows on the first floor are double hung, and the front window consists of a large single sash, with leaded transome. Two smaller fixed sash windows are located on either side of front door. The front door is wood with a single rectangular glass pane. A veranda wraps around the front and west side of the house. The veranda roof is supported by six classical columns mounted on a solid wood balustrade. The veranda ends at a second doorway, along the side wing. A small bay window protrudes from the first floor west wall. A one and a half story addition is located on the east wall. This appears to be a covered entrance to the second story, and has an exterior staircase extending out to the rear of the building. A single story addition, with a flat roof is located to the rear of the building. Foundation material is cast stone. Concrete steps extend away from the porch towards the front walkway. Some landscaping is present.

This particular building is significant under the Architecture and Construction Theme. It is an interesting example of the Colonial Revival style through the use of the classical columns and prominent front gable. The second story of the building appears to have been altered, and the windows on the second floor have been replaced on the front and west side by aluminum sliders. A second story entrance was also added at a later time, sometime after 1928, since this feature does not appear in the Sanborn map for 1928. This building appears to have been built sometime between 1903 and 1907, possible by George M. Dana who owned the property from 1906 to 1910. In 1910, the property was transferred to J.F. Davies who owned it to 1915 when it transferred to Elizabeth Davies. It is not known whether they are related. Elizabeth Davies owned the property until 1945, when it was transferred to Emmett L. and Stella S. Sisson who owned it until 1947, when it transferred to G.W. and Mildred L. Barrett.

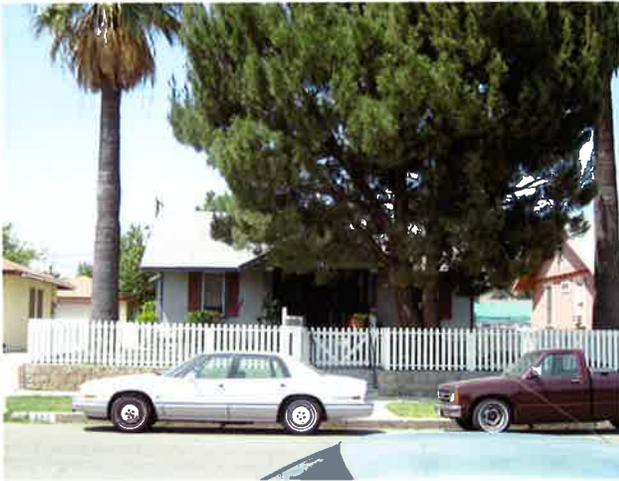
A single story, rectangular shaped building of wood construction on an north/south orientation in the Craftsman style. Roof is front gable.
