Supplemental Hazardous Materials Survey

**Barton Road Bridge Removal and Road Construction
Project No. BRLS-5065(024); Bridge No. 54C-0379
Barton Road, West of Grand Terrace Road
Colton and Grand Terrace, San Bernardino County, CA**

January 21, 2021
Terracon Project No. CB175228

SUPPLEMENTAL HAZARDOUS MATERIALS SURVEY REPORT

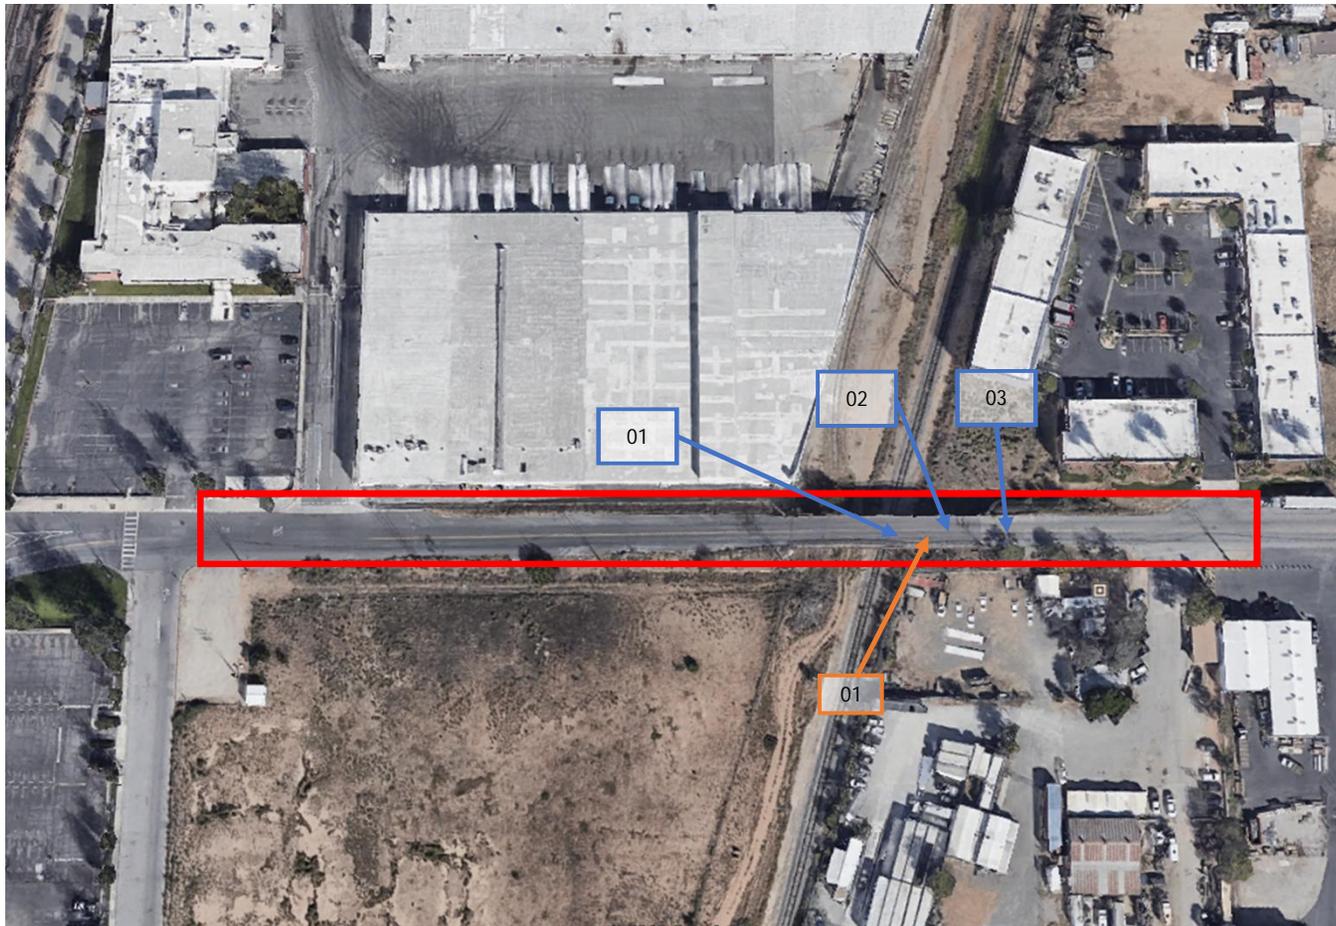
Lead and Chromium Samples

Survey Area

Prepared for: CNS Engineers, Inc.
Project: Supplemental Hazardous Materials Survey
Scale: Not to Scale
Terracon Project Number: CB175228

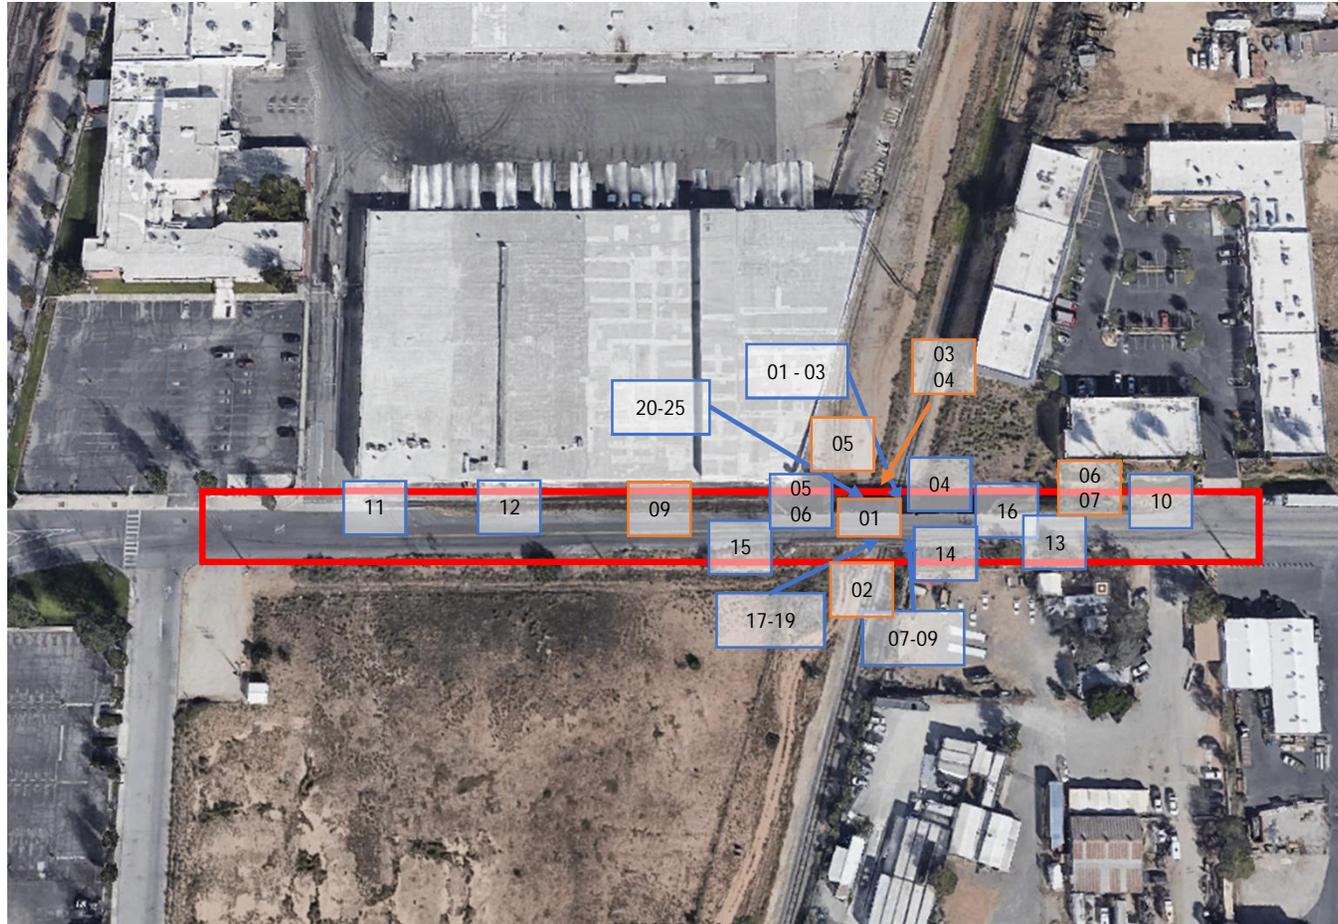
Lead and Chromium
Samples

Survey Area

Prepared for: CNS Engineers, Inc.
Project: Pre Demolition Hazardous Materials
Survey
Scale: Not to Scale
Terracon Project Number: CB175228
