# 115, 125, 133 and 135 N. Pennsylvania Ave

## Historical Resource Assessment Report

**July 2020**

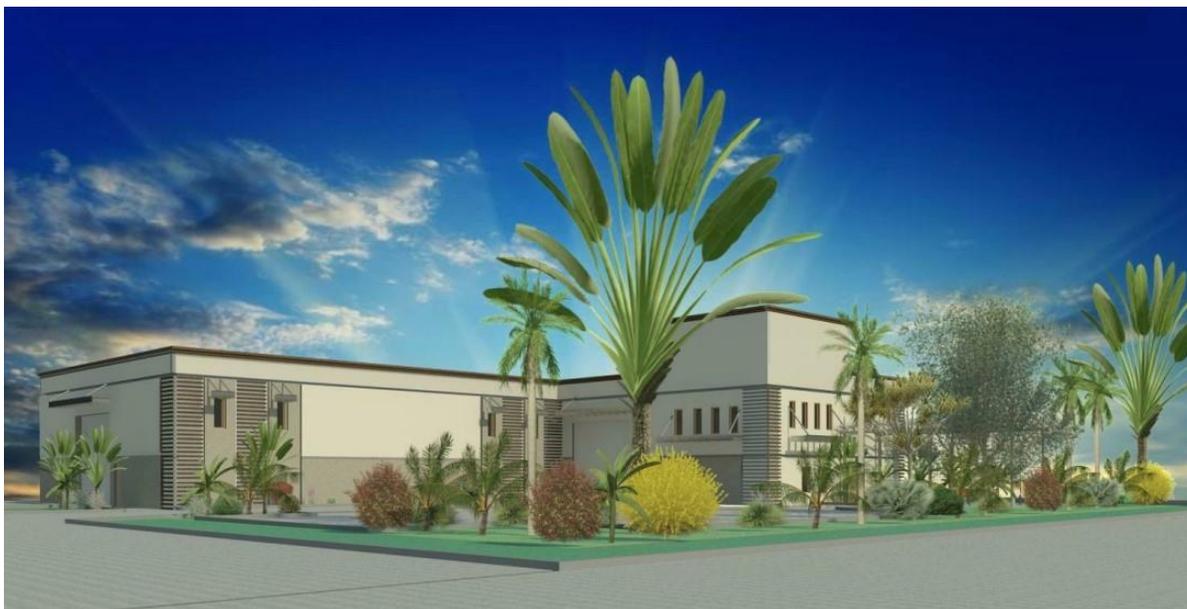
**Figure 1 Proposed Project - Architect's Rendering**

The proposed project would expand the existing Amko Recycling facility which presently occupies the property directly across the street to the east (340 West Valley Boulevard) and a property slightly to the north adjacent to the alley (157 North Pennsylvania Avenue). Implementation of the proposed project would entail constructing a new building in order to move Amko's buy-back center, which serves the public, to the west side of Pennsylvania Avenue, while maintaining its larger-scale services for commercial customers at the existing facility on the east side of Pennsylvania Avenue (See Figure 1). As part of the project, the four residences at 115, 125, 133 and 135 North Pennsylvania Avenue would be demolished and the vacant parcel abutting them on the west would be developed.

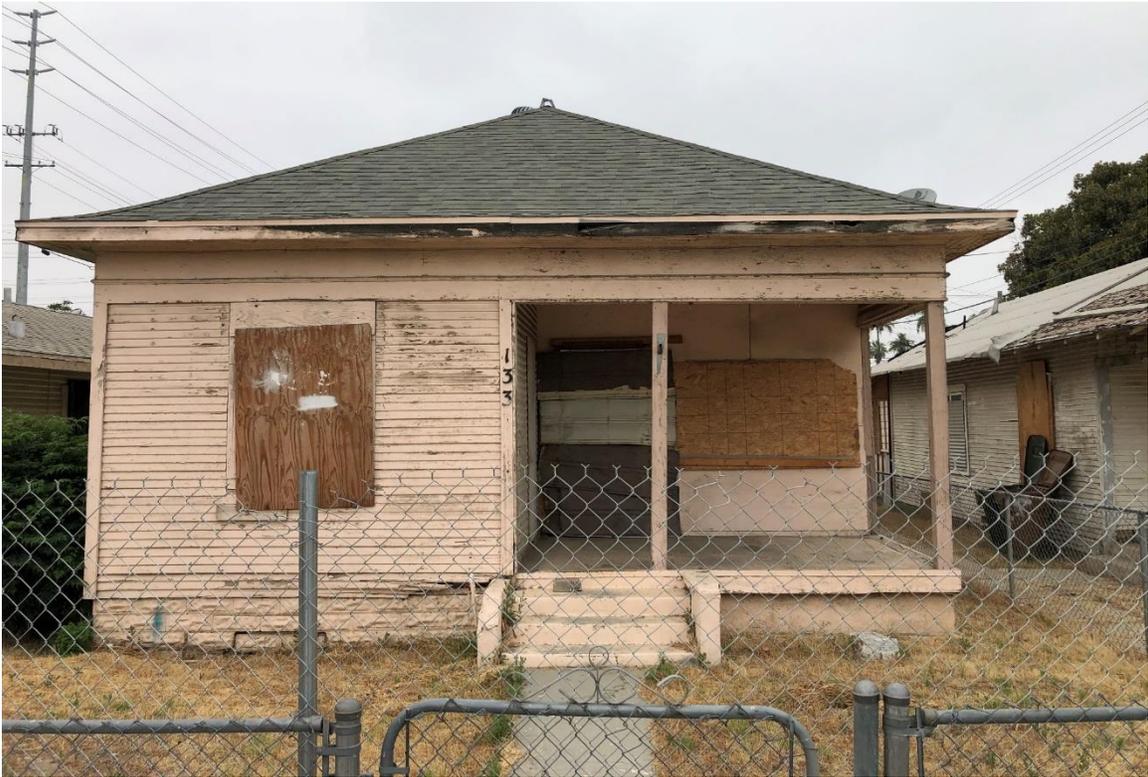
The home at 133 North Pennsylvania Avenue is sited on the large central parcel which contains one additional single-family residence slightly to the south. Constructed in 1901, 133 North Pennsylvania Avenue has a rectangular footprint and appears to rest on a concrete foundation although plyboard and corrugated metal panels cover much of the foundation like skirting. Its hipped roof has shallow, closed eaves and is clad with composite shingles. The home is sheathed with a variety of original and replacement materials including horizontal channel siding, narrower clapboard siding, vertical wooden siding, plyboard, and what appears to be vertical wood panels. Its primary entry, on the eastern façade, is accessed via concrete steps leading to a partial-width, recessed porch which is supported by square wooden posts. Panels have been nailed over the primary entry door for security reasons (Figure 5). The west elevation exhibits considerable alteration which appears to be an enclosure of the porch and an addition across the rear of the home (Figure 6). The addition is topped by a shed roof clad with composite shingles, and a roof overhang shelters an entry door and concrete steps. The addition's exterior is clad with various types of siding, including vertical wooden boards of different widths and plyboard (Figure 7). Windows are currently covered with plyboard. Where siding is missing, wall studs and portions of the building interior are exposed (Figure 8). The home's quality of materials is poor and it is in severe disrepair.

**Figure 5 133 North Pennsylvania Avenue, Eastern Façade, View West**

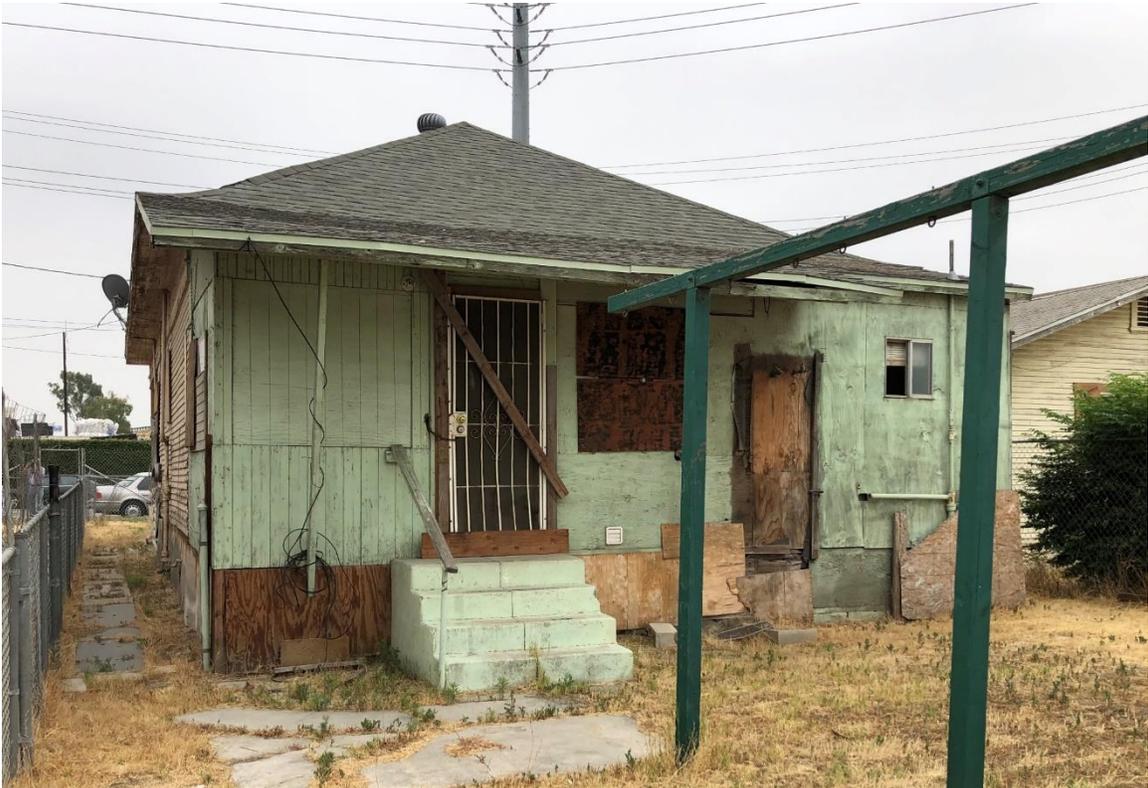
**Figure 6 133 North Pennsylvania Avenue, West (Rear) Elevation, View Southeast**

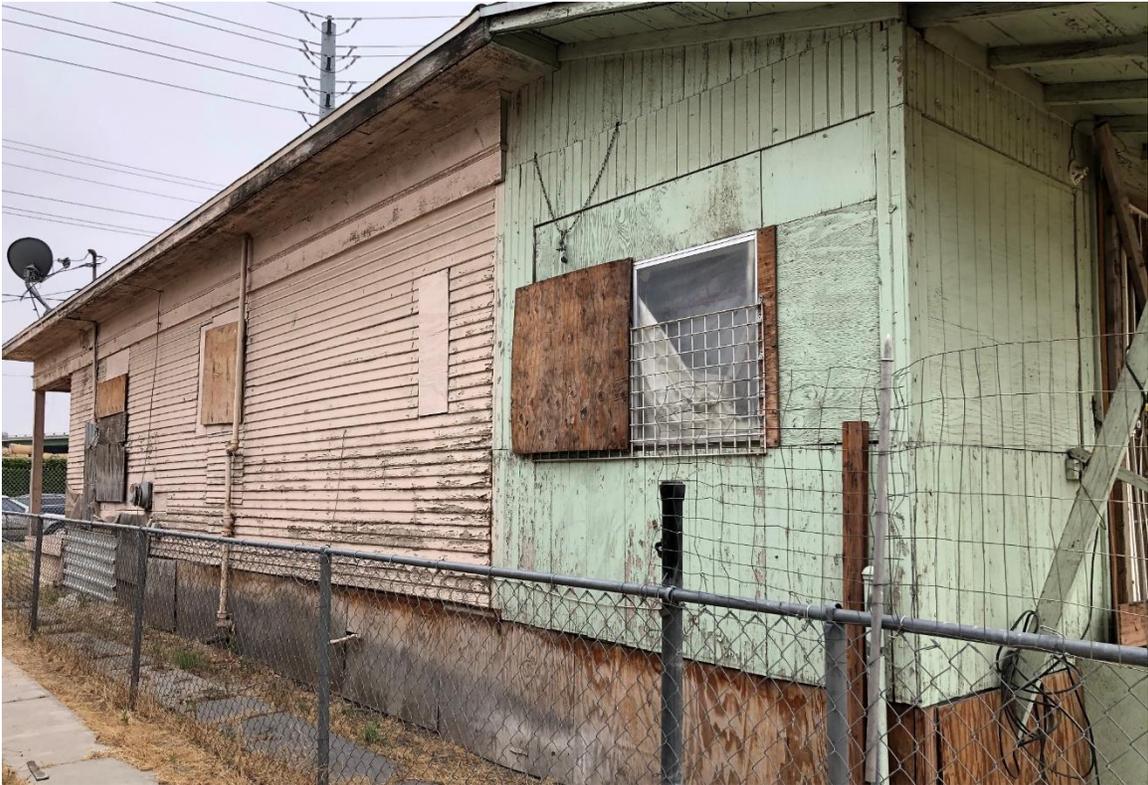
**Figure 7 133 North Pennsylvania Avenue, North Elevation, View Southeast**

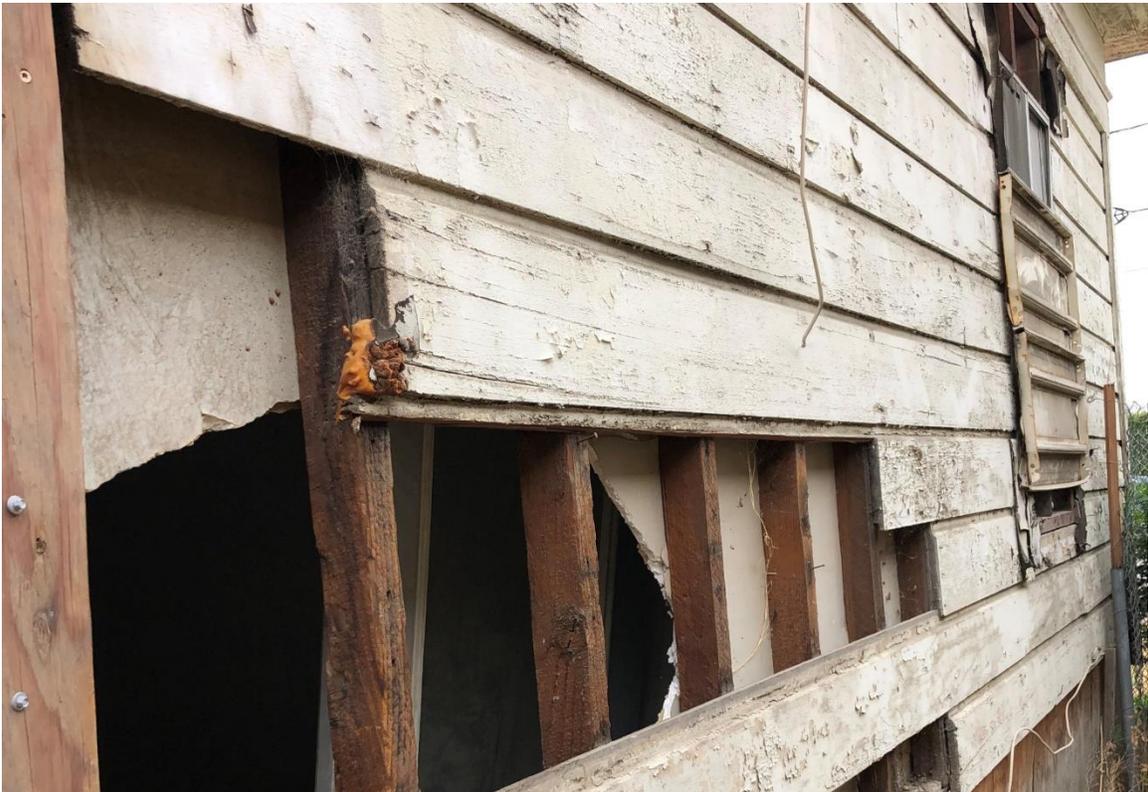
**Figure 8 133 North Pennsylvania Avenue, Closeup of Siding**

Although City staff did not locate any building permit records for the property, visual observation demonstrates extensive alterations have been made to the home as previously described above. This includes the porch enclosure and addition at the rear of the home, addition of plyboard and corrugated metal panels around the base/foundation, replacement of areas of original siding, and areas of missing siding which expose studs and the building's interior.

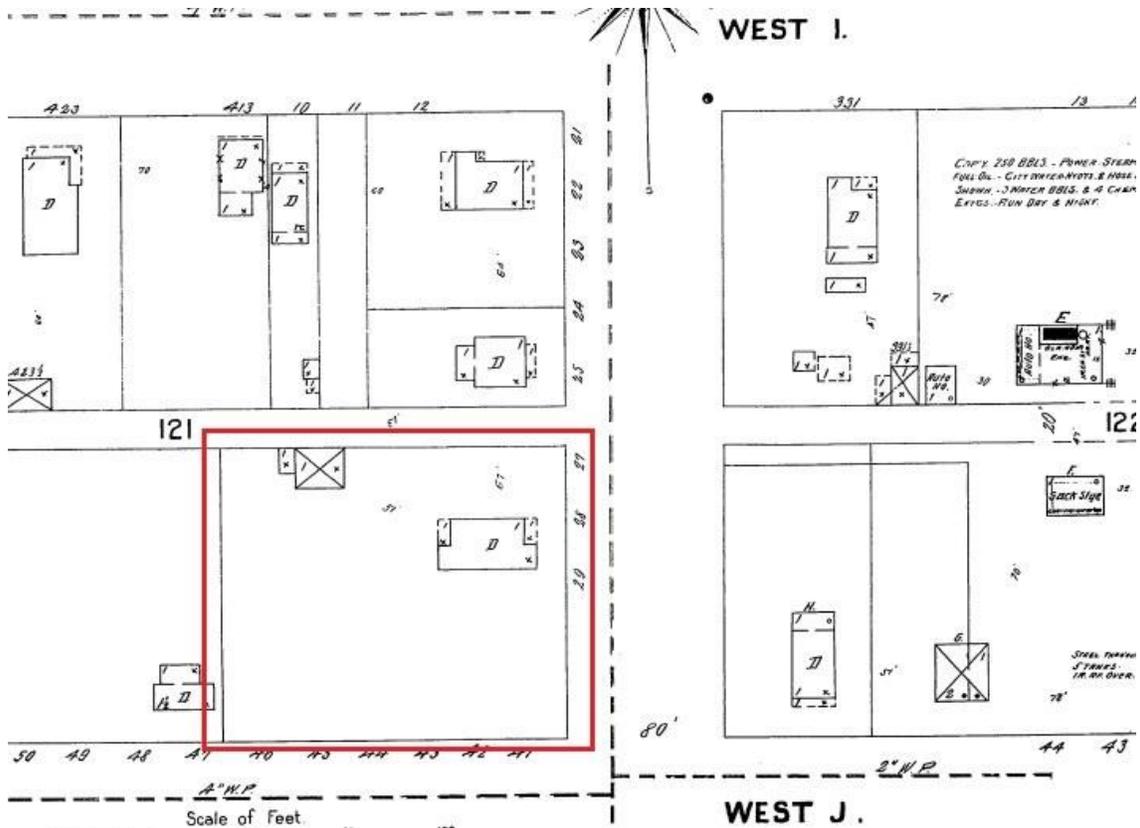
Starting early in the 20<sup>th</sup> century, over the decades, various buildings have been built and removed to the rear of the home, near the northwestern edge of the property (Figure 9 and Figure 10). However, none of those buildings are extant (Sanborn-Perris Map Co. 1907, 1911, 1928, 1950).

Figure 9 133 N. Pennsylvania Ave on 1907 Sanborn Map

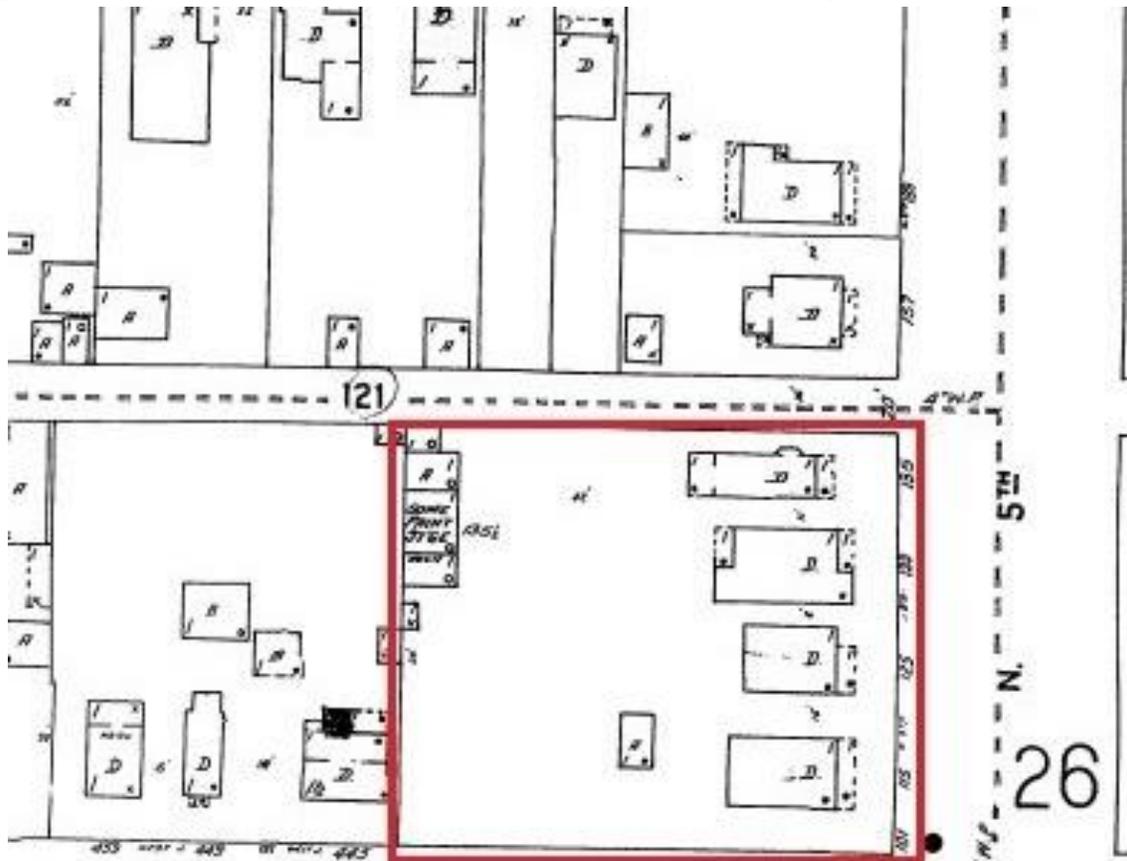
**Figure 10** 115 - 135 N. Pennsylvania Ave and Ancillary Buildings on 1955 Sanborn Map

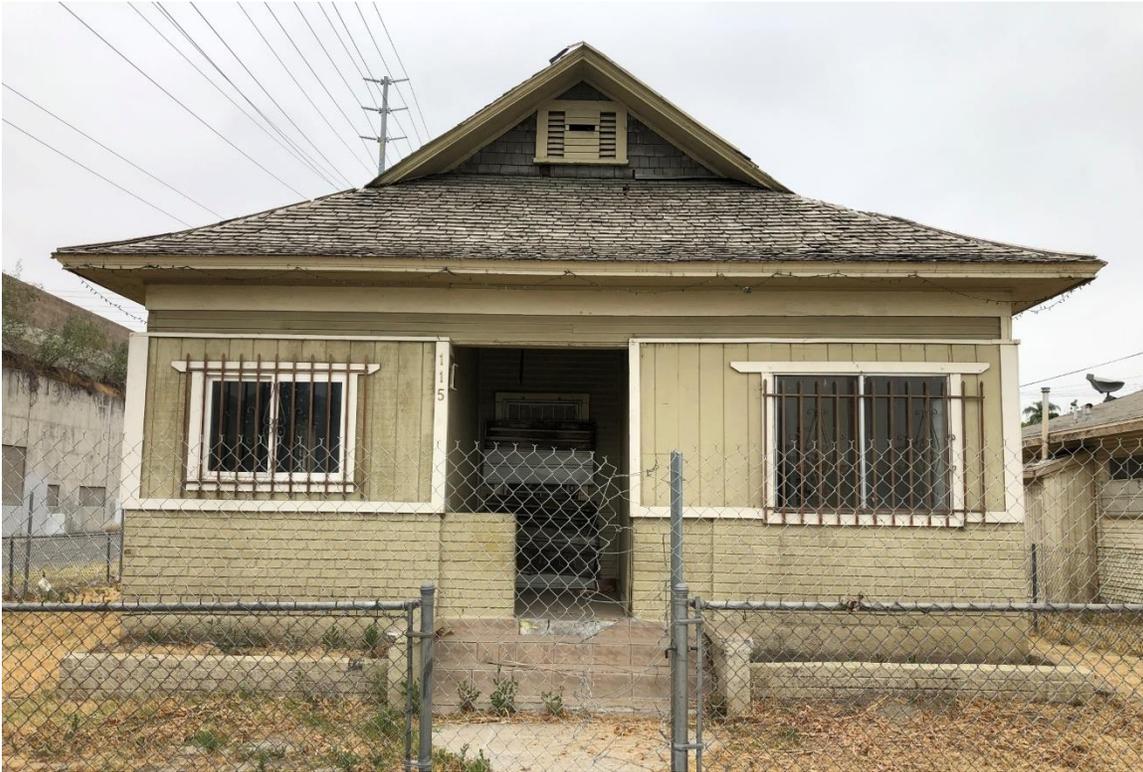
The home at 115 North Pennsylvania Avenue is situated on the southernmost parcel adjacent to J Street. Constructed between 1907 and 1910, 115 North Pennsylvania Avenue has a rectangular footprint and rests on a concrete and concrete block foundation. It is topped by a gable-on-hip roof with shallow, closed eaves, and is covered with composite shingles. Slatted vents are located on the east and west gables. Smaller gables, similar to dormers, are located on the north and south sides of the home, and contain similar vents. The home is sheathed in a variety of replacement and original siding including horizontal channel siding, narrower clapboard siding, vertical wooden siding, plyboard, and what appears to be vertical wood panels. The home's primary entry, on the eastern façade, is deeply recessed due to the original full-width porch being enclosed (Figure 11). As a result, the façade has brick construction on the lower portion of the walls and wide vertical siding or wood panels on the upper portion of the walls (Figure 12). The entry stoop and steps have been covered with large, non-original tile. A metal security door obscures view of the front entry door, and additionally, ridged metal panels have been nailed over the door for security reasons. A secondary entry is located on the rear (west) elevation, which is accessed by a set of concrete steps with a metal railing. The door is obscured by a metal security door and additionally, ridged metal panels have been nailed over it for security reasons. Attached to the northwest corner of the home is a small shed roof covered with tar paper and supported by wooden posts. In this area, the home's exterior shows various types of siding indicating replacement or alteration (Figure 13). Windows have been replaced throughout the home and currently include aluminum and vinyl-sash sliders. Window size/openings have also been altered (Figure 14). Some windows have iron grilles applied over them for security reasons and some windows are currently covered with plyboard. The home's quality of materials is poor and it is in disrepair.

**Figure 11 115 North Pennsylvania Avenue, Eastern Façade, View West**

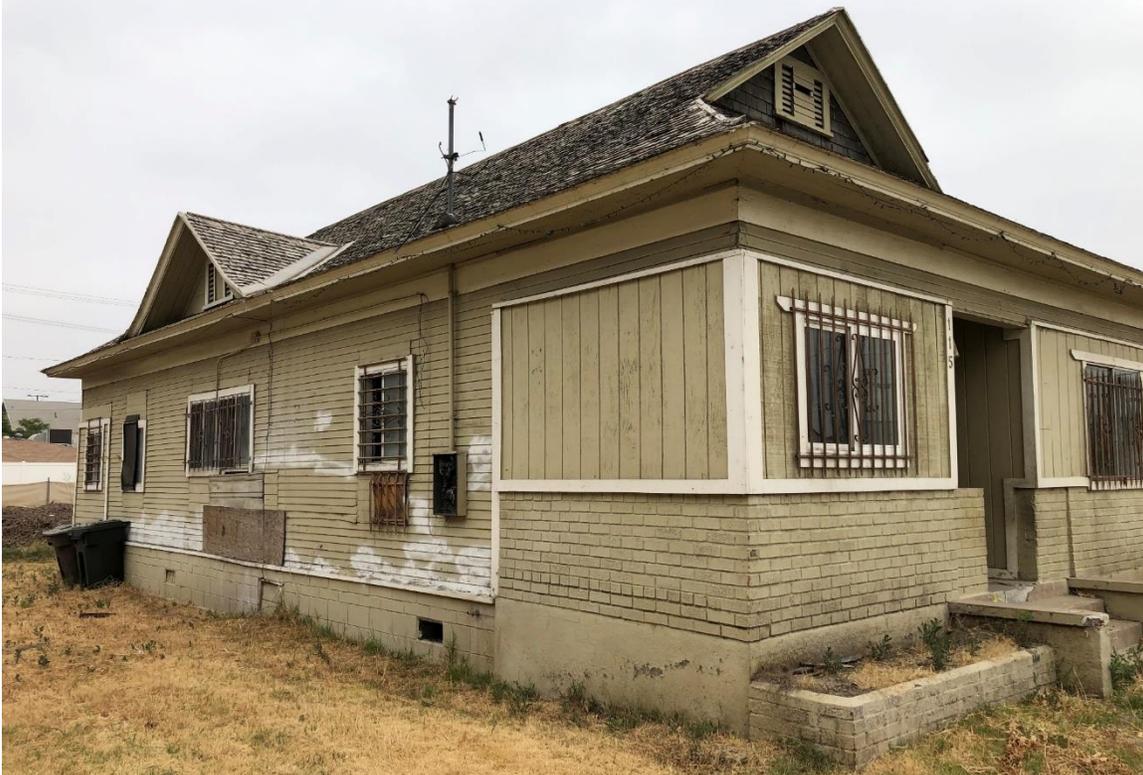
**Figure 12 115 North Pennsylvania Avenue, East and South Elevations, View Northwest**

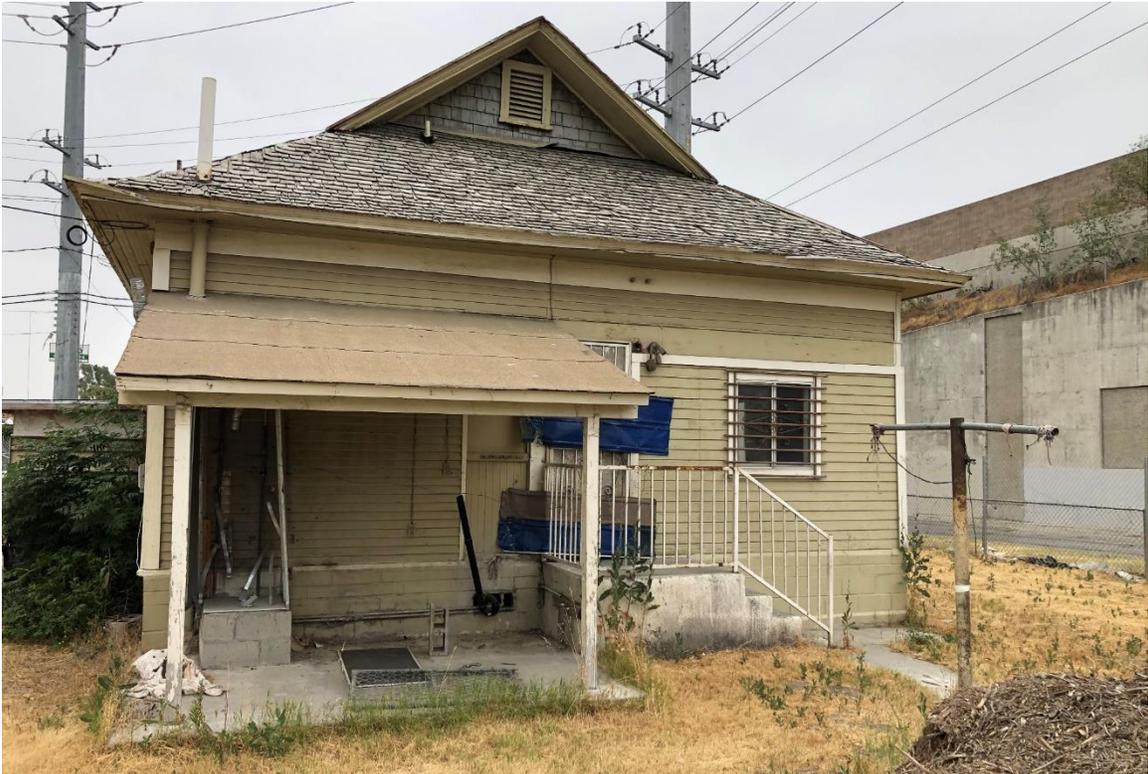
**Figure 13 115 North Pennsylvania Avenue, West (Rear) Elevation, View Southeast**

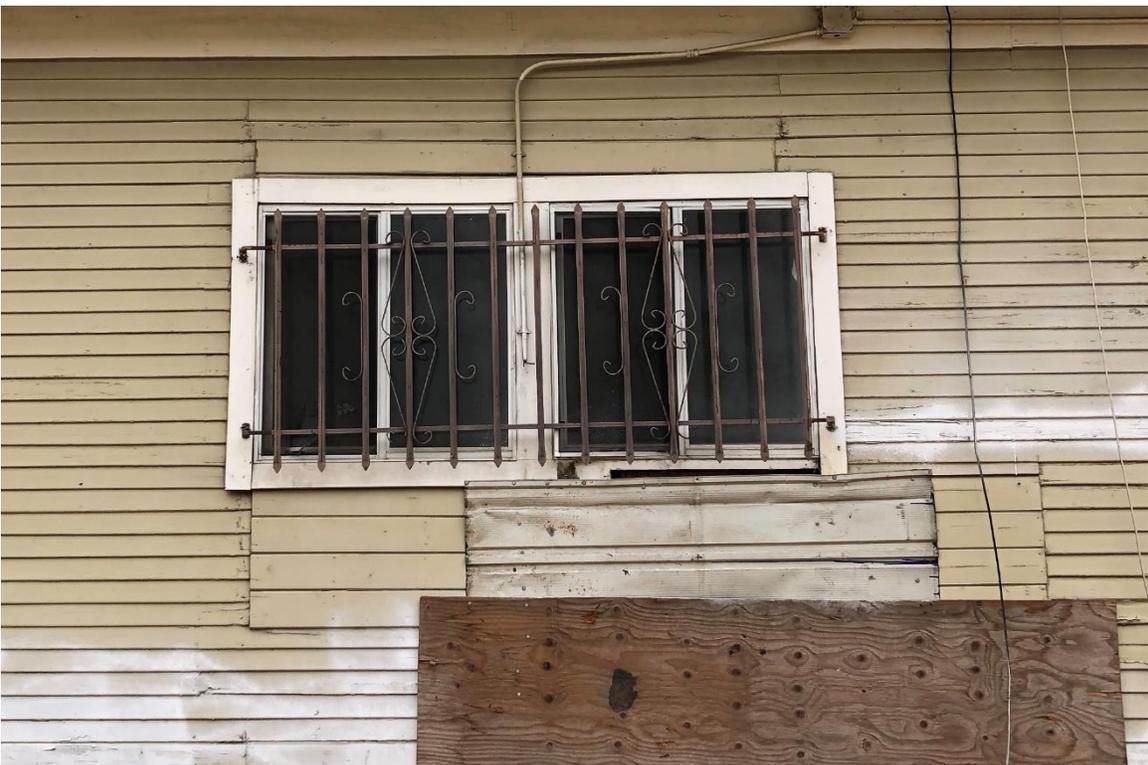
**Figure 14 115 North Pennsylvania Avenue, Closeup of Window and Siding Alterations**

Although City staff did not locate any building permit records for the property, visual observation indicates considerable alterations have been made to the home as previously described above. This includes replacement of the original windows, alteration of windows size/openings, addition of a shed roof on the rear (west) elevation, replacement of areas of original siding, enclosure of the original full-width front porch which created a deeply recessed primary entrance, and non-original tile on the entry stoop and steps.

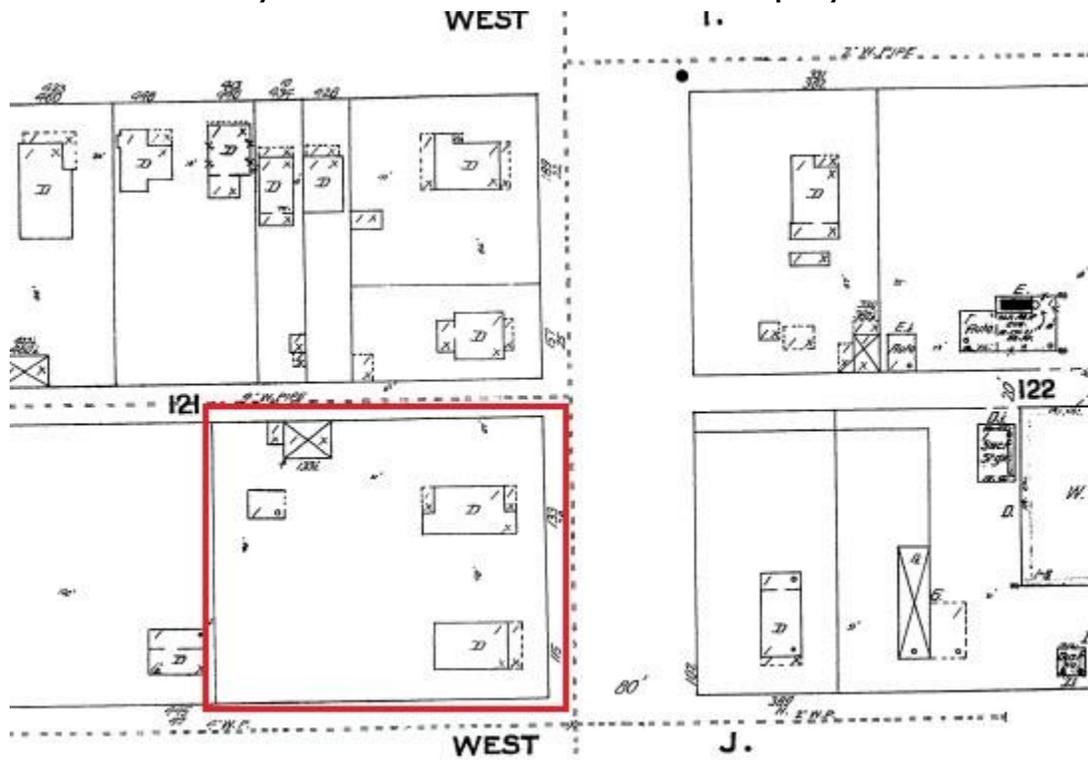
The home at 115 North Pennsylvania Avenue was built between 1907 and 1910 at the southeast edge of the property adjacent to J Street (Sanborn-Perris Map Co. 1907 and 1911; United States Census 1910) (Figure 15). It was the second home built on the large parcel which spanned from J Street to the alley, and was originally addressed as 115 North 5th Street. As built, the home had a rectangular footprint with a full-width porch spanning across the eastern façade.

**Figure 15 115 N. Pennsylvania Ave at Southeast Corner of Property on 1911 Sanborn Map**

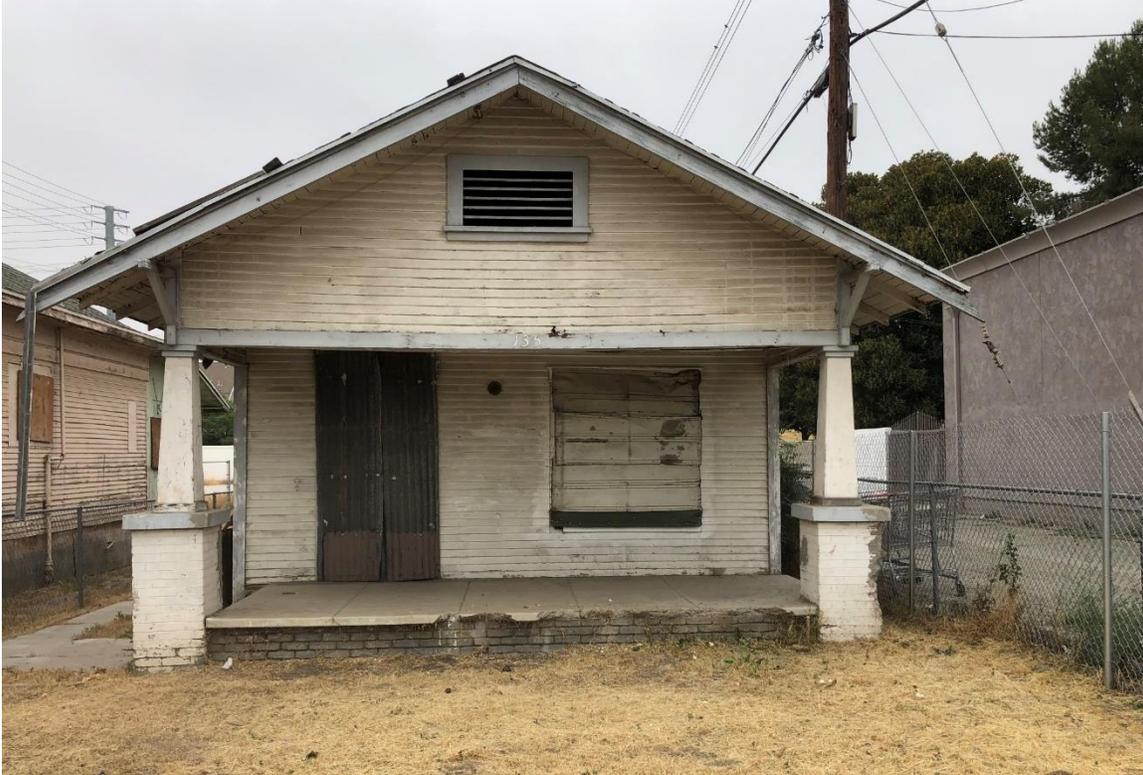
The home at 135 North Pennsylvania Avenue is situated on the northernmost parcel adjacent to the alley. Built in 1922 as a modest Craftsman-inspired bungalow, the home has a rectangular footprint and a moderately-pitched gabled roof with overhanging eaves and exposed rafter tails (Figure 16). The roof is covered with rolled roofing material. Resting on a concrete and brick foundation, the home is sheathed in horizontal clapboard and has slatted vents on the front and rear gables. Its primary entry, on the eastern façade, is accessed via a full-width, recessed porch which is supported by two tapered wooden posts resting on square brick pillars. Concrete steps are located on the south end of the porch. The primary entry door is obscured by corrugated metal panels that have been applied over it for security reasons. An addition was constructed across the west (rear) elevation (Figure 17). It is topped by a shed roof clad with rolled roofing material, and its roof overhang creates a porch supported by square wooden posts. The addition’s exterior is sheathed

**Figure 16 135 North Pennsylvania Avenue, Eastern Façade, View West**

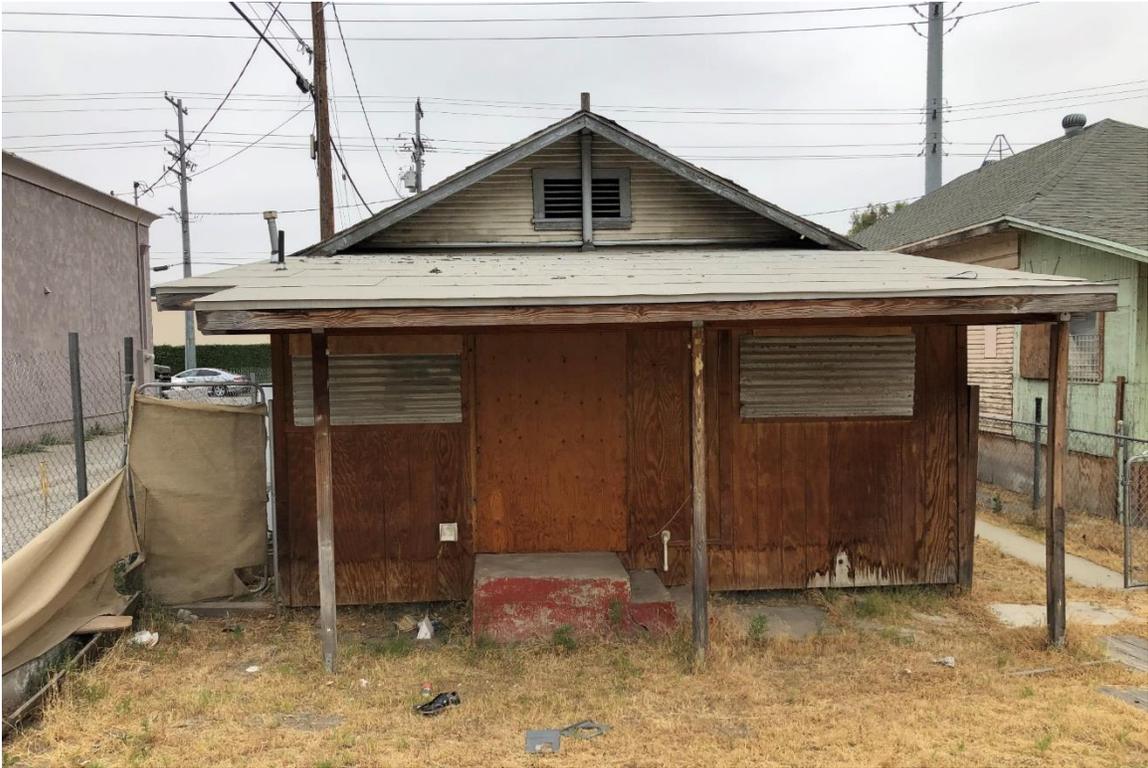
**Figure 17 135 North Pennsylvania Avenue, Western (Rear) Elevation, View East**

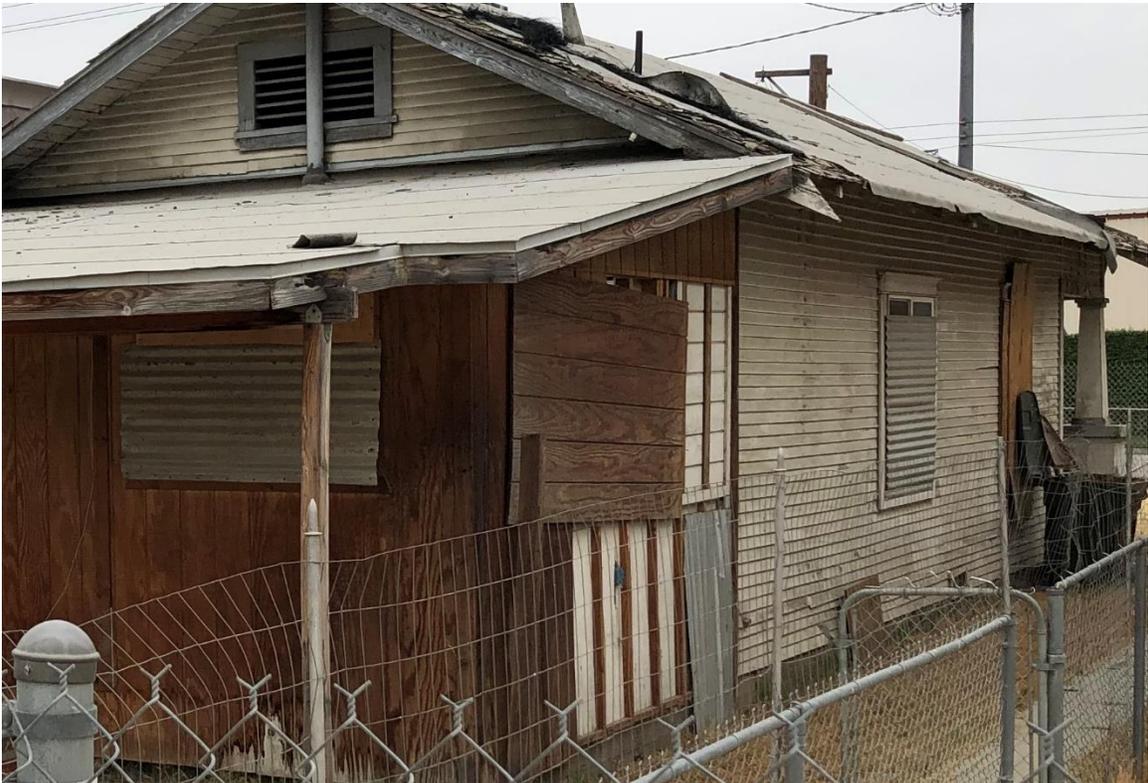
with various types of siding, including what appears to be wood panel siding, board-and-batten, and plyboard (Figure 18). A secondary entry door, which is accessed via concrete steps, is covered by plyboard. In some areas, vinyl-sash sliders and some of the original window surrounds are visible; however, windows are covered with ridged metal panels, corrugated metal panels and plyboard for security reasons. The home's quality of materials is poor and it is in disrepair.

**Figure 18 135 North Pennsylvania Avenue, Closeup of Alterations, View Northeast**

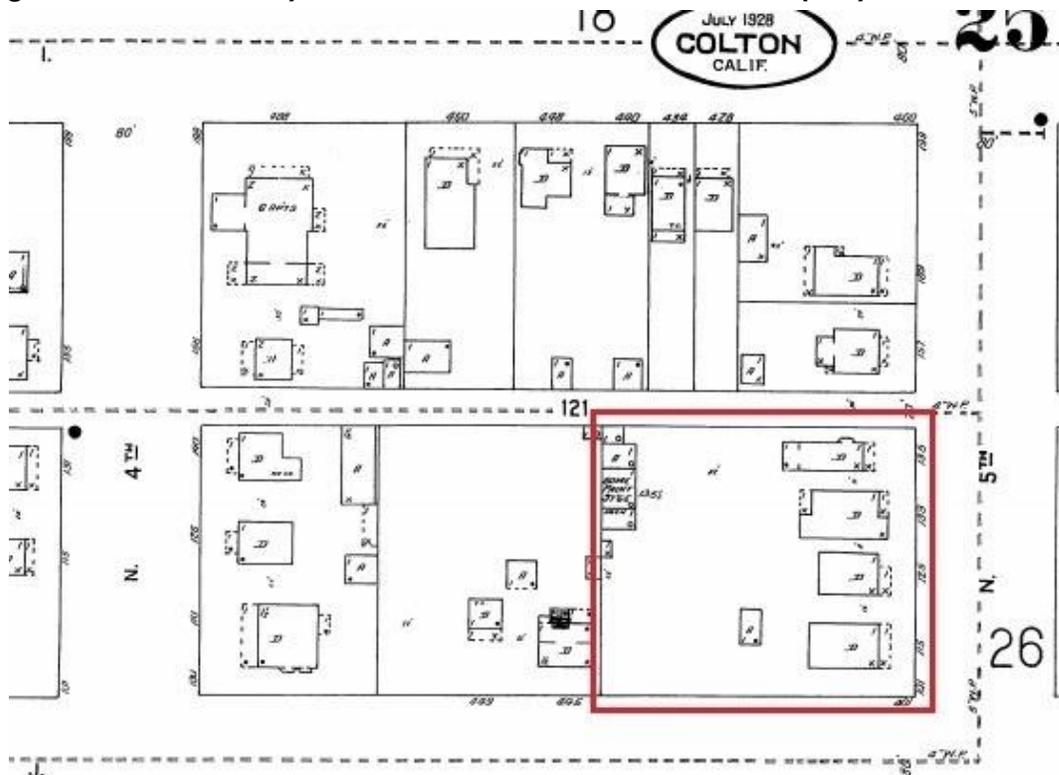
The home at 135 North Pennsylvania Avenue was constructed in 1922 (San Bernardino County Assessor). Located adjacent to the alley at the northeast corner of the property, it was the third home built on the large parcel between J Street and the alley. Originally, the home was addressed as 135 North 5th Street. City records did not include the original building permit, and the original property owner and builder were not ascertained. Lewis J. Feldman was the earliest occupant identified in 1930 (Personal communication with Marion Murphy, June 22, 2020). No consequential information was found on this individual. A grouping of small, one-story ancillary buildings were once located to the rear of 135 and 133 North Pennsylvania Avenue. Labeled as 135 ½ [North 5<sup>th</sup> Street], descriptions on Sanborn maps included an auto garage and “Some paint st’ge” (likely storage) (Figure 19). The buildings were removed or demolished by the 1960s (NETRonline 1968).

**Figure 19 135 N. Pennsylvania Ave at Northeast Corner of Property on 1928 Sanborn Map**

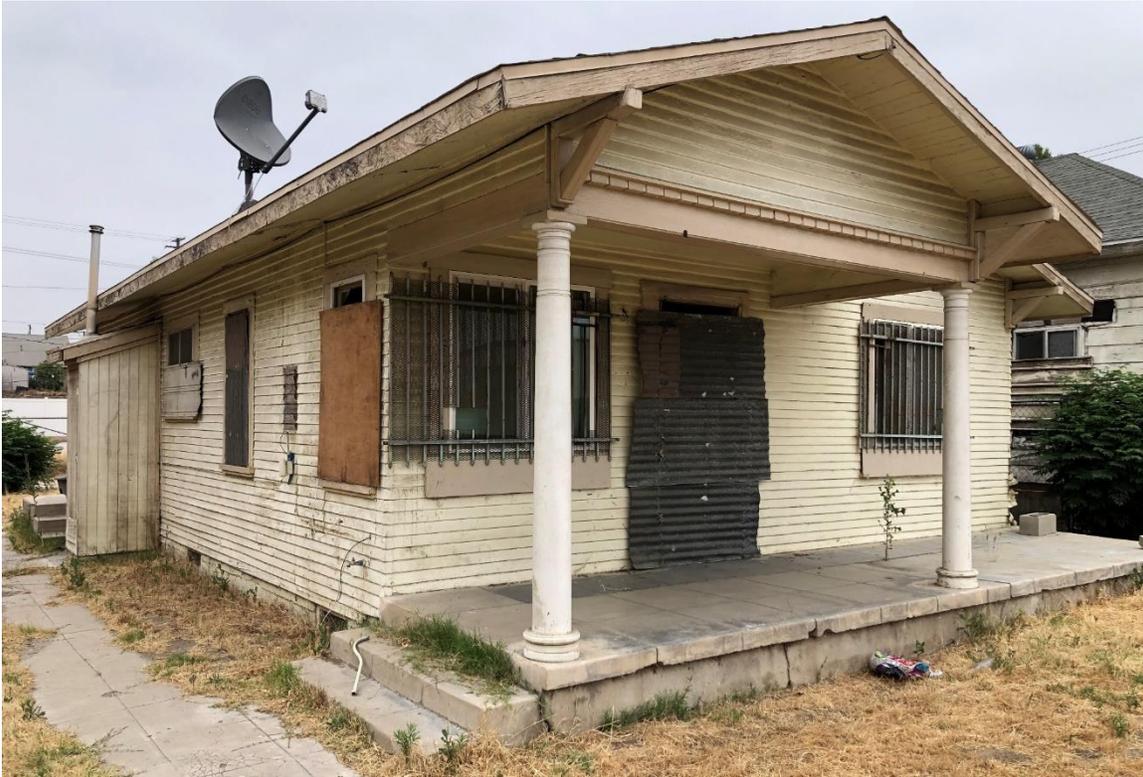
The home at 125 North Pennsylvania Avenue is situated on the central parcel which also includes 133 North Pennsylvania Avenue to the north. Built in 1926, the home has a L-shaped footprint and rests on a concrete foundation (Figure 20 and Figure 21). Its moderately-pitched gabled roof has overhanging, closed eaves and appears to be clad with composite shingles. The home is sheathed primarily in horizontal clapboard. Slatted vents are located on the east and west gables. Its primary entry, on the eastern façade, is accessed via a partial-width, projecting porch supported by Ionic columns which are likely not original. The entry door is covered by corrugated metal panels for security reasons. A secondary entry is located near the southwest corner; in this area vertical wood paneling which differs from the rest of the home indicates alteration (Figure 22). Windows include vinyl-sash sliders; some show the original wood casing. Windows are covered with metal grilles, wooden boards, corrugated metal panels and plyboard for security reasons. The home’s quality of materials is poor and it is in disrepair.

**Figure 20 125 North Pennsylvania Avenue, Eastern façade and South Elevation, View Northwest**

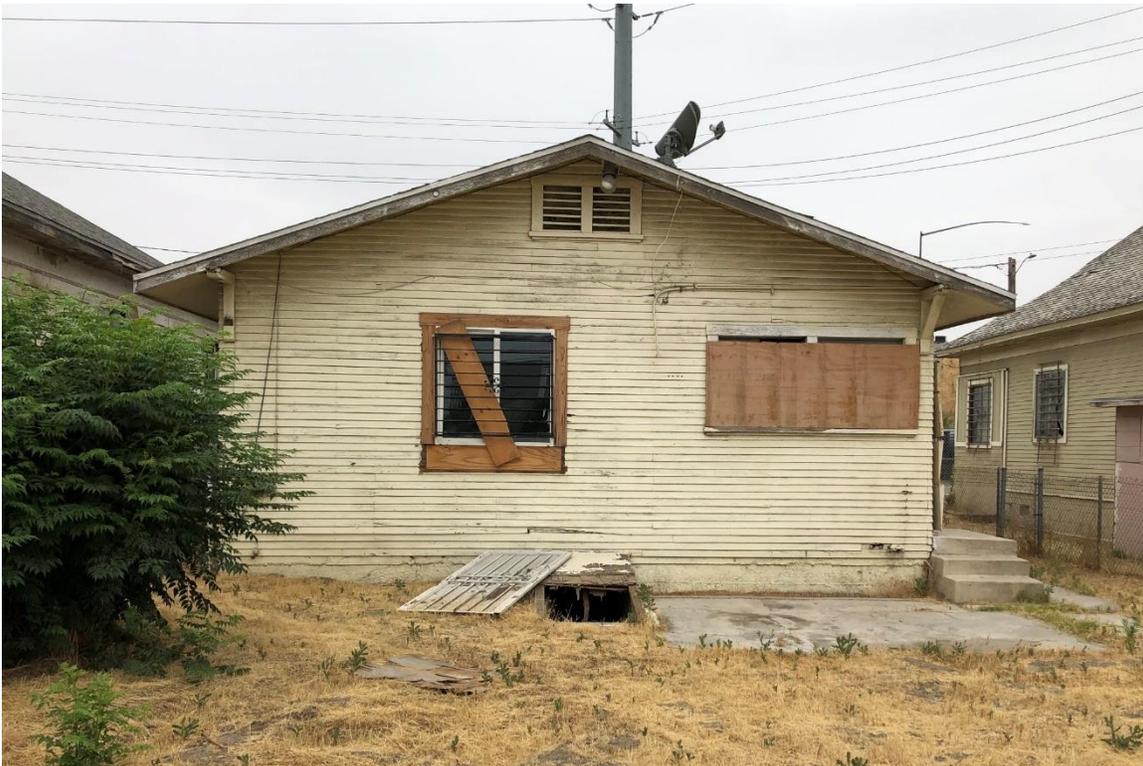
**Figure 21 125 North Pennsylvania Avenue, West (Rear) Elevation, View East**

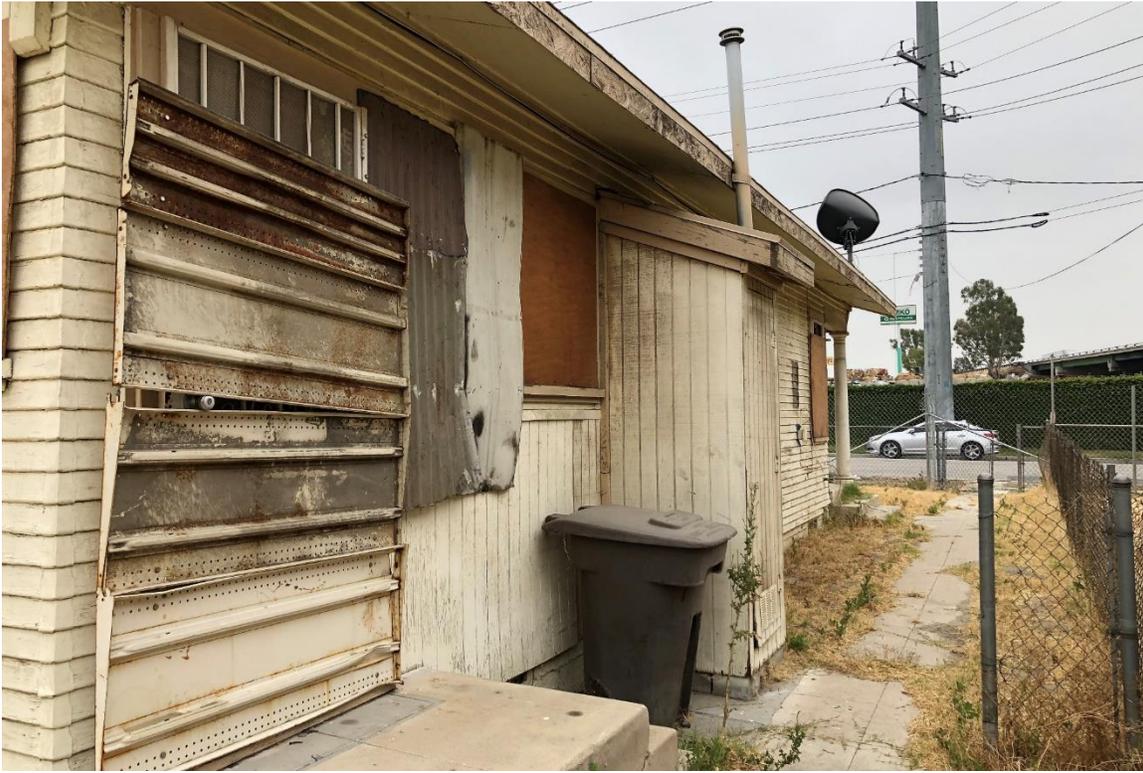
**Figure 22 125 North Pennsylvania Avenue, Closeup of Alterations on South Elevation**

The home at 125 North Pennsylvania Avenue was constructed in 1926 (San Bernardino County Assessor). It was the last of the four homes built on the large parcel spanning between J Street and the alley and was originally addressed as 125 North 5th Street. City staff did not locate any building permit records, and the original property owner and builder were not ascertained. However, visual observation demonstrates alterations have been made to the home as previously described above. These include: replacement vinyl-sash windows, replaced exterior siding and porch columns. Doors and windows have been covered with metal grilles, wooden boards, corrugated metal panels and plyboard.

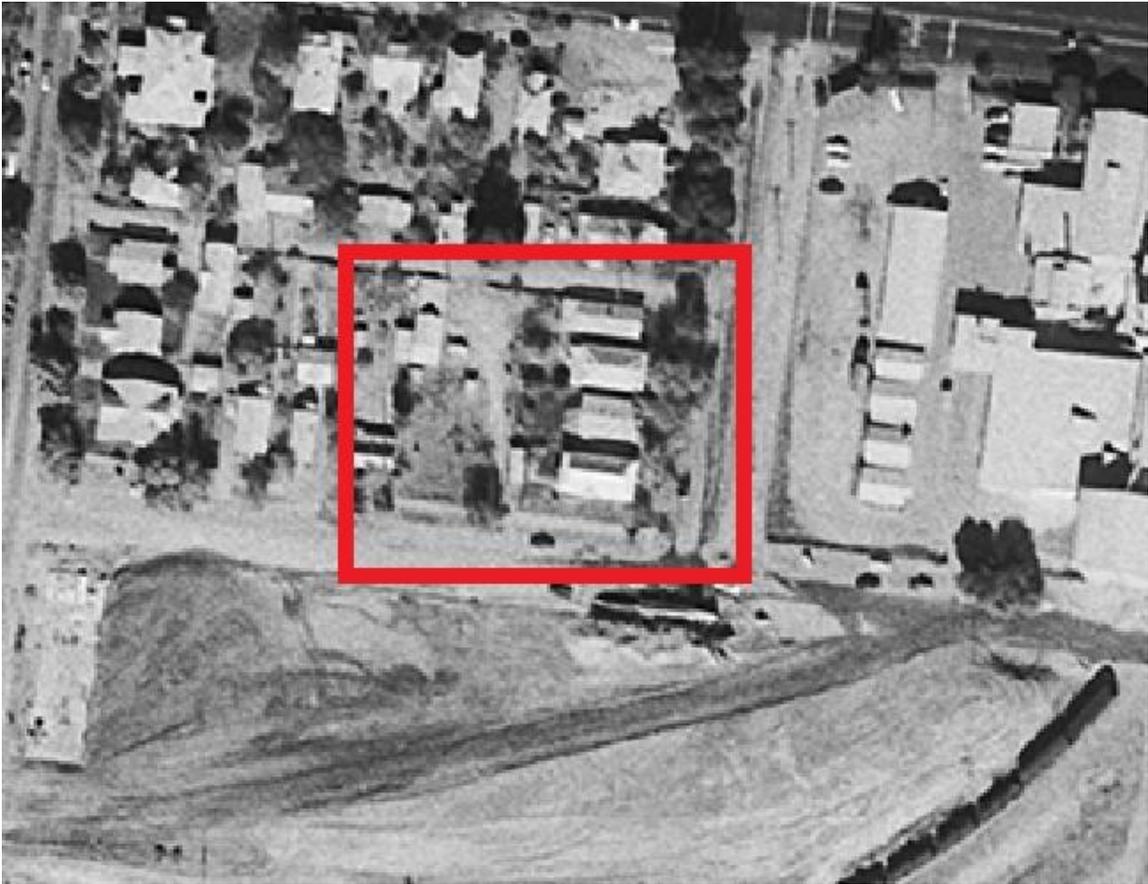
Since the time of the four homes' construction, various changes have occurred to the property and surrounding setting (Figure 23). The once larger parcel was formally subdivided into four smaller parcels at an unknown time. The various ancillary buildings and automobile garages once located to the rear (west) of the four homes were removed or demolished by the 1960s (NETRonline 1959 and 1966). Considerable changes to the properties' setting have occurred - between 1955 and 1959 Interstate 10 was constructed in close proximity to the south (approximately 60 to 175 feet away, depending on the residence), resulting in the demolition of many properties in the area of J Street (U.C. Santa Barbara Map & Imagery Lab 1955; NETRonline 1959). In addition, properties slightly to the north along I Street between 5<sup>th</sup> and 4<sup>th</sup> streets appear to have been redeveloped between 1955 and 1980 (U.C. Santa Barbara Map & Imagery Lab 1955; NETRonline 1980). More recently, in 2005, a residence at 529 West J Street was constructed 1 ½ blocks to the west as infill within the Terrace Historic District (San Bernardino County PIMS). Numerous other properties throughout The terrace District boundaries show evidence of having been altered with replacement windows, exterior stucco and additions.

**Figure 23 115-135 N. Pennsylvania Ave and Ancillary Buildings on a 1955 Aerial Photo**
