PHASE I
ENVIRONMENTAL SITE ASSESSMENT

Colton Super Block,
Approximately 353 Acre Site Roughly
Bounded by San Bernardino Avenue,
Riverside Avenue, I-10 Freeway,
and Hermosa Avenue,
City of Colton and City of Rialto,
County of San Bernardino, California

Final Report

May 30, 2008
J.N. 149-08

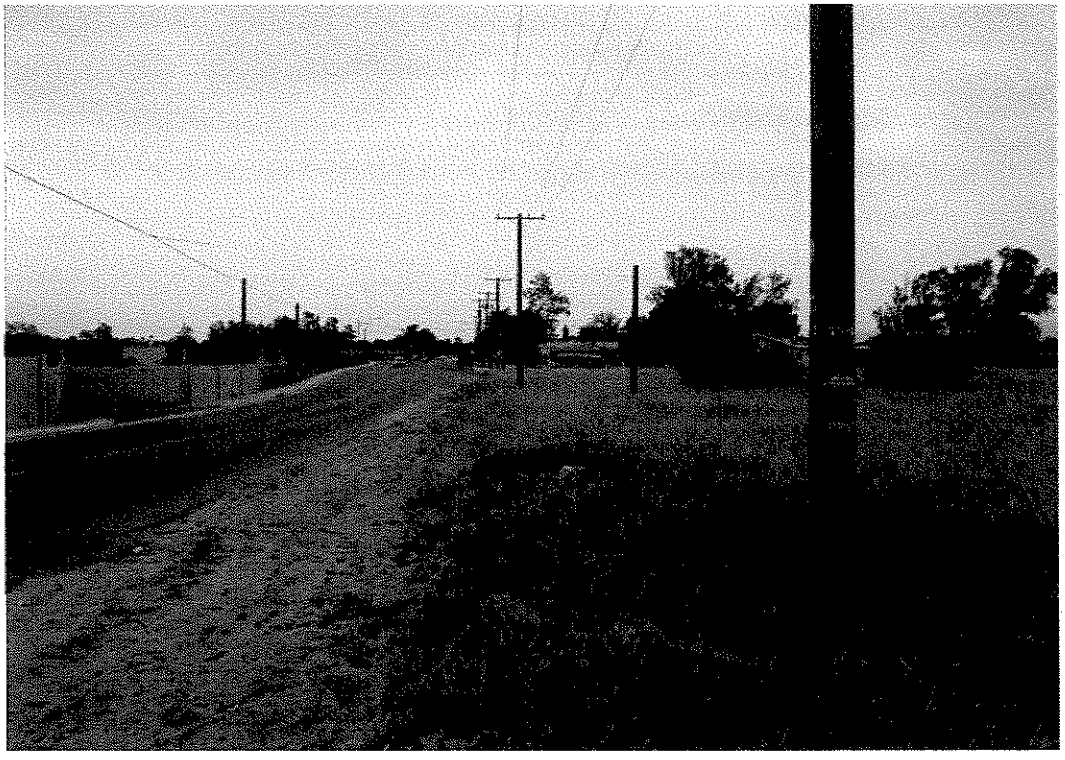
View East Along West C Street from the intersection of West C Street and Meridian Avenue.

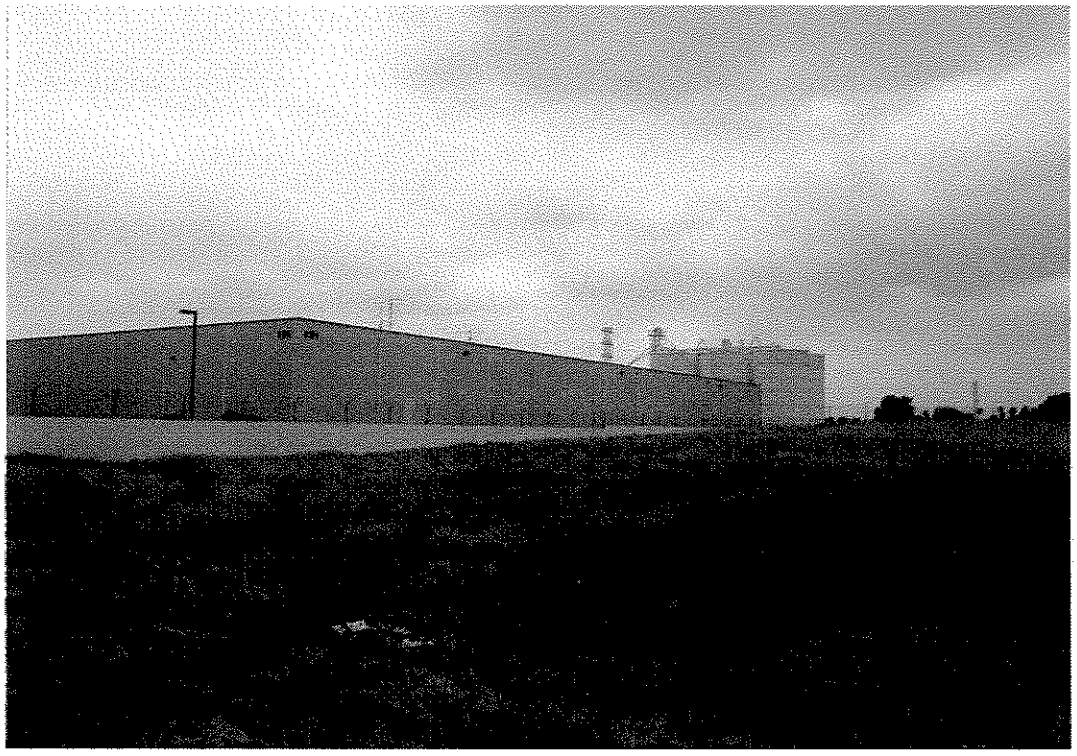
View of 791 Pepper Avenue.

It is recommended that these facilities be inspected. The ASTs should be inspected to confirm they are placed within secondary containment units.

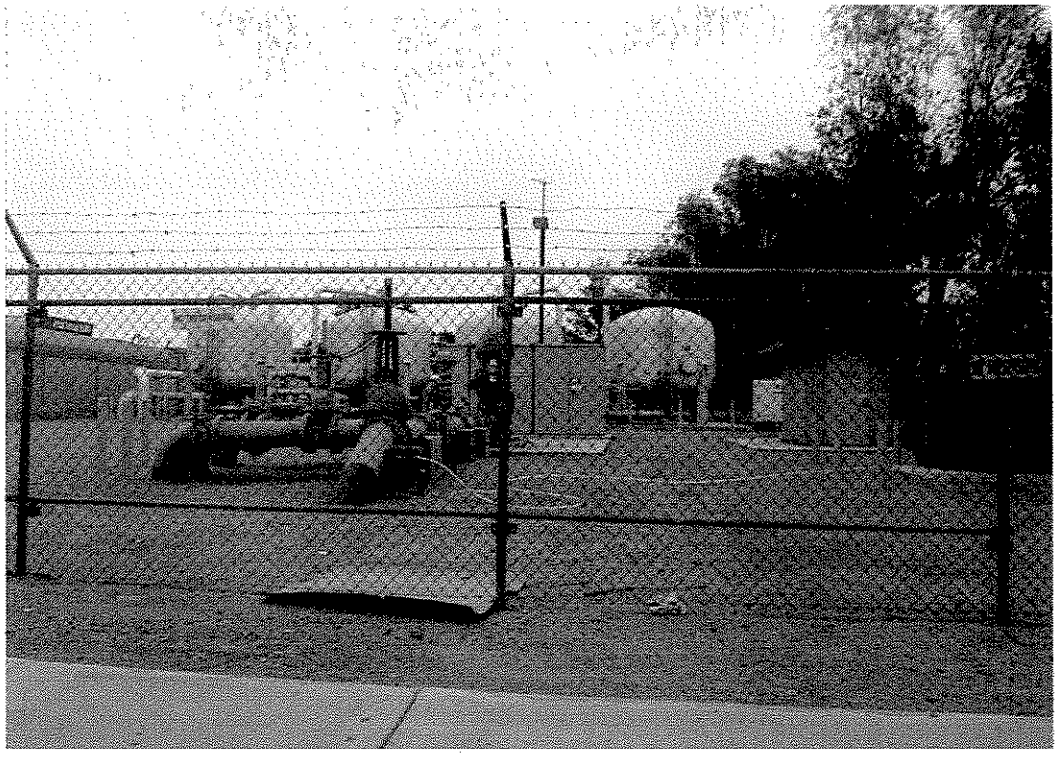
Well Structure Located on the Southwestern Corner of the Site.

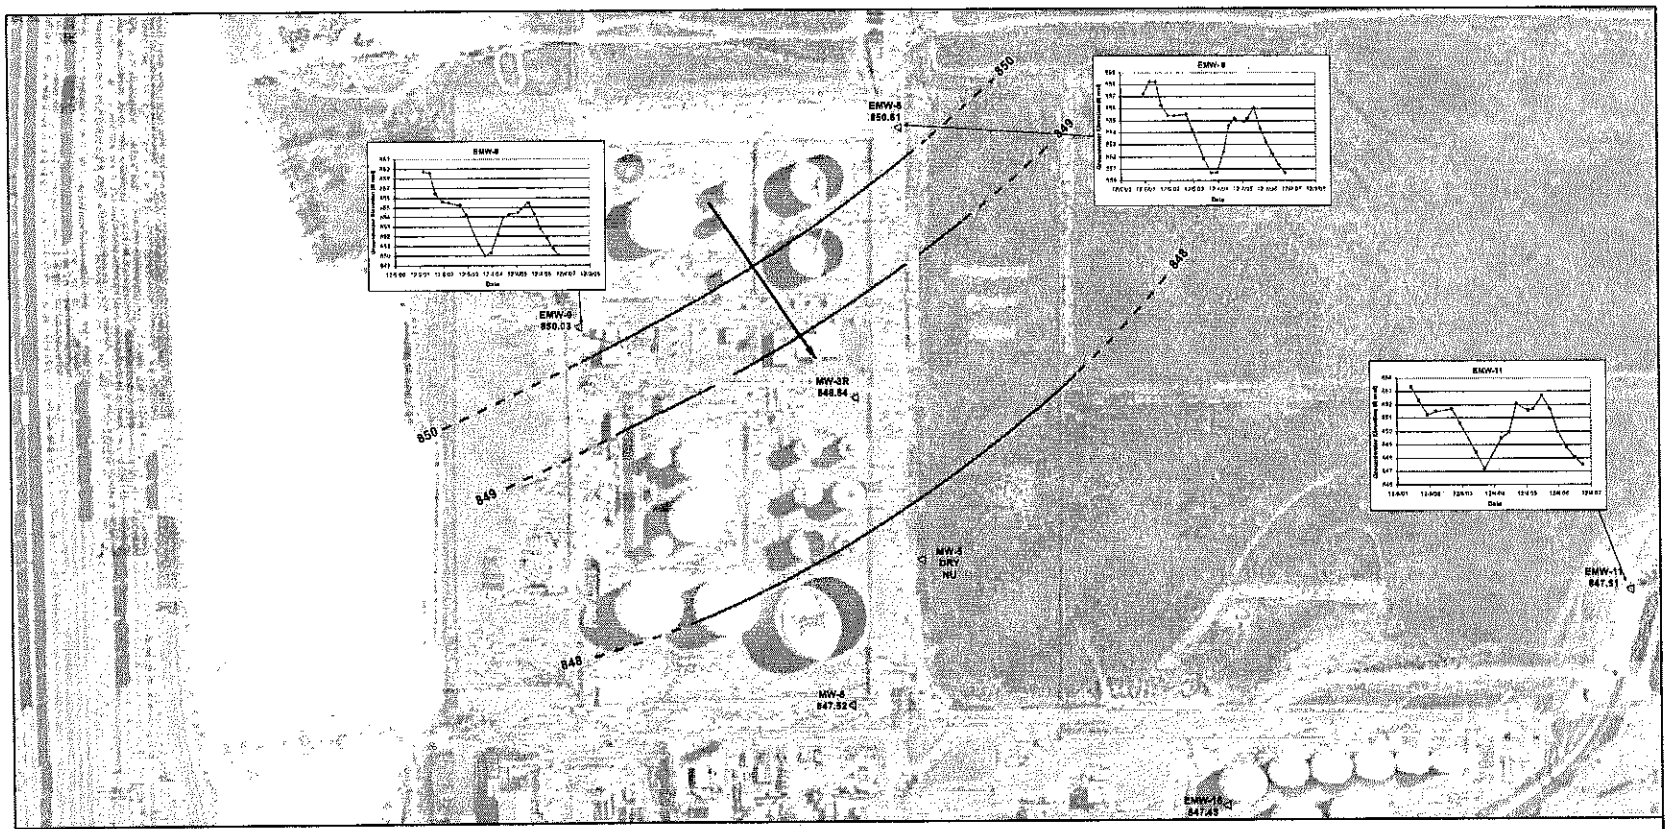
Figure 3-2
Groundwater Elevations
Regional Water Table Aquifer
Third Quarter 2007

The groundwater flow conditions in the regional water table aquifer are generally consistent with those observed during the Second Quarter 2007. Groundwater elevations in the regional water table aquifer ranged from 850.61 feet msl in well EMW-8 (located in the southeast corner of the Terminal) to 847.45 feet msl in EMW-16 (located southwest of the Terminal). The groundwater flow direction is to the southwest with an average hydraulic gradient of 0.0033 ft/ft. Groundwater elevations in the regional water table aquifer wells increased by an average of 0.63 foot since last quarter (Figure 3-2; Table 3-1).

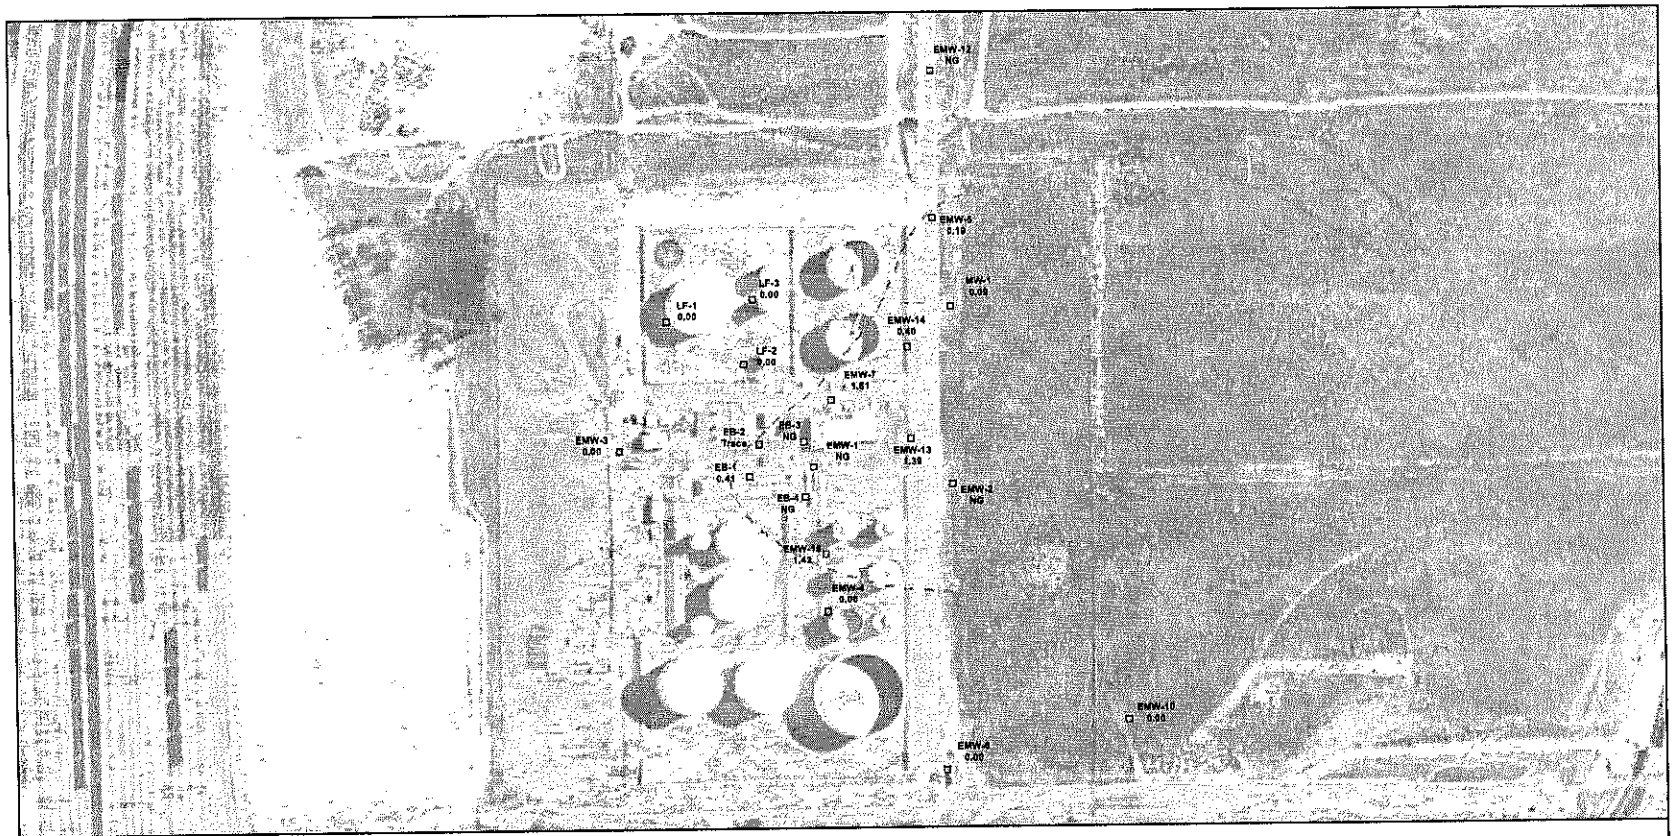
Figure 3-3
LNAPL Distribution
Perching Silt Unit
Third Quarter 2007

The distribution of LNAPL observed during the Third Quarter 2007 in the perching silt unit wells is shown in Figure 3-3. LNAPL was measured in eight wells (EB-1, EB-2, EMW-5, EMW-7, EMW-13, EMW-14, EMW-15, and MW-1). LNAPL thicknesses ranged from 0.09 foot in MW-1 to 1.51 feet in newly installed EMW-7. Only a trace of LNAPL was observed in EB-2.

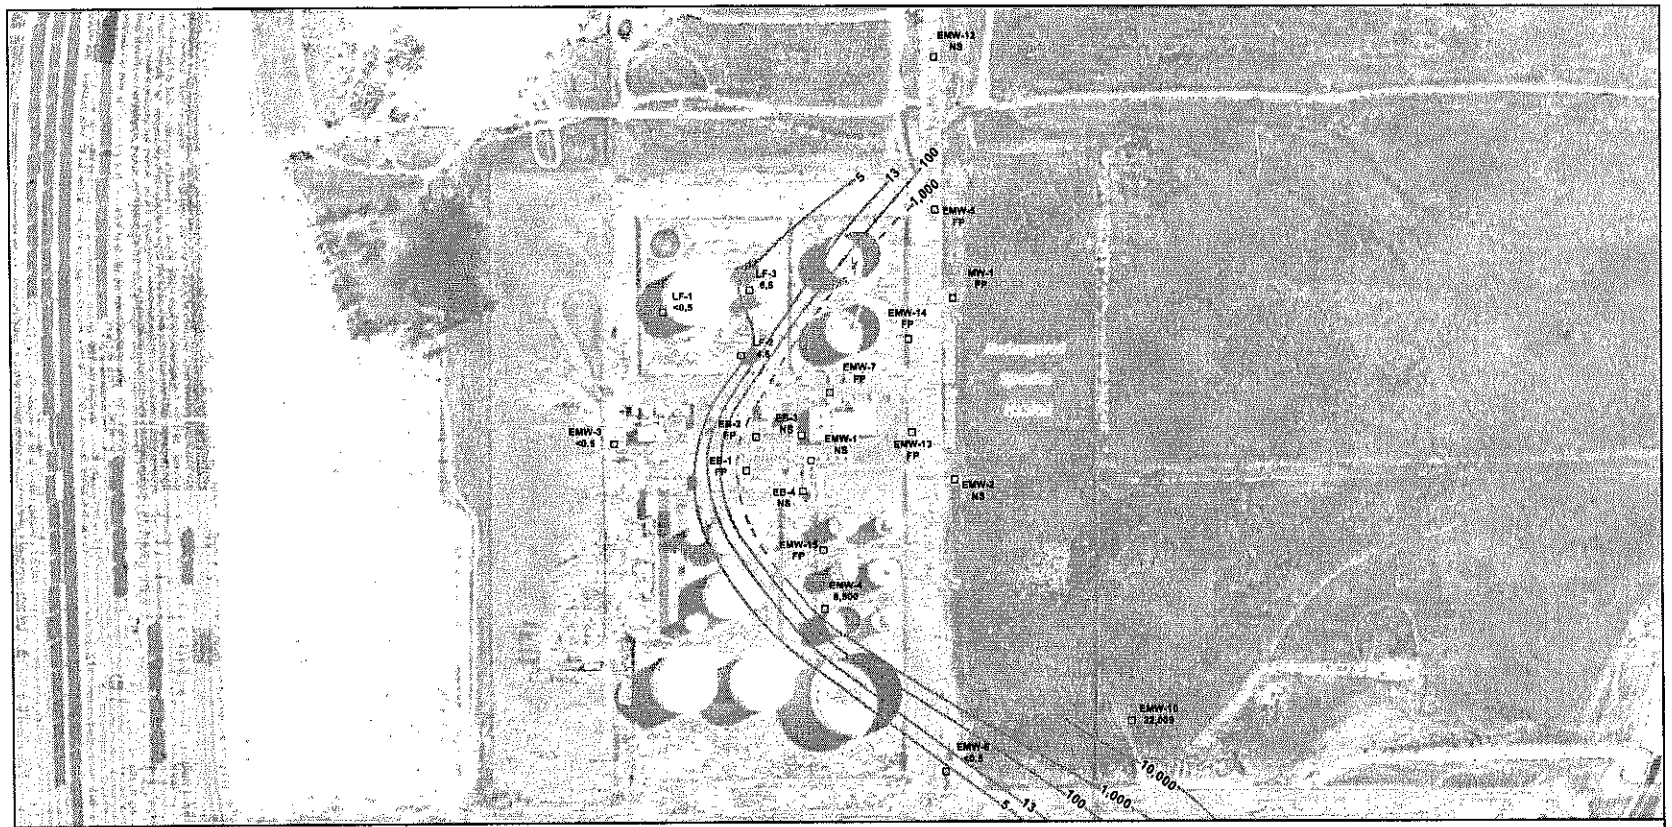
Figure 3-5
MTBE Distribution
Perching Silt Unit
Third Quarter 2007

MTBE was detected in four monitoring wells this quarter: EMW-4, EMW-10, LF-2, and LF-3 (Figure 3-5). The maximum MTBE concentration during the Third Quarter 2007 was reported in EMW-10 (32,000 µg/L). Compared to the Second Quarter 2007, MTBE concentrations for the Third Quarter 2007 have increased in two wells (LF-3 and EMW-4) and decreased in two wells (EMW-10 and LF-2). One well had the highest MTBE concentration reported to date (EMW-4 at 8,500 µg/L); one well had the second lowest concentration reported to date (LF-2 at 4.6 µg/L). MTBE concentrations were not reported in three wells (LF-1, EMW-3, and EMW-6) this quarter.

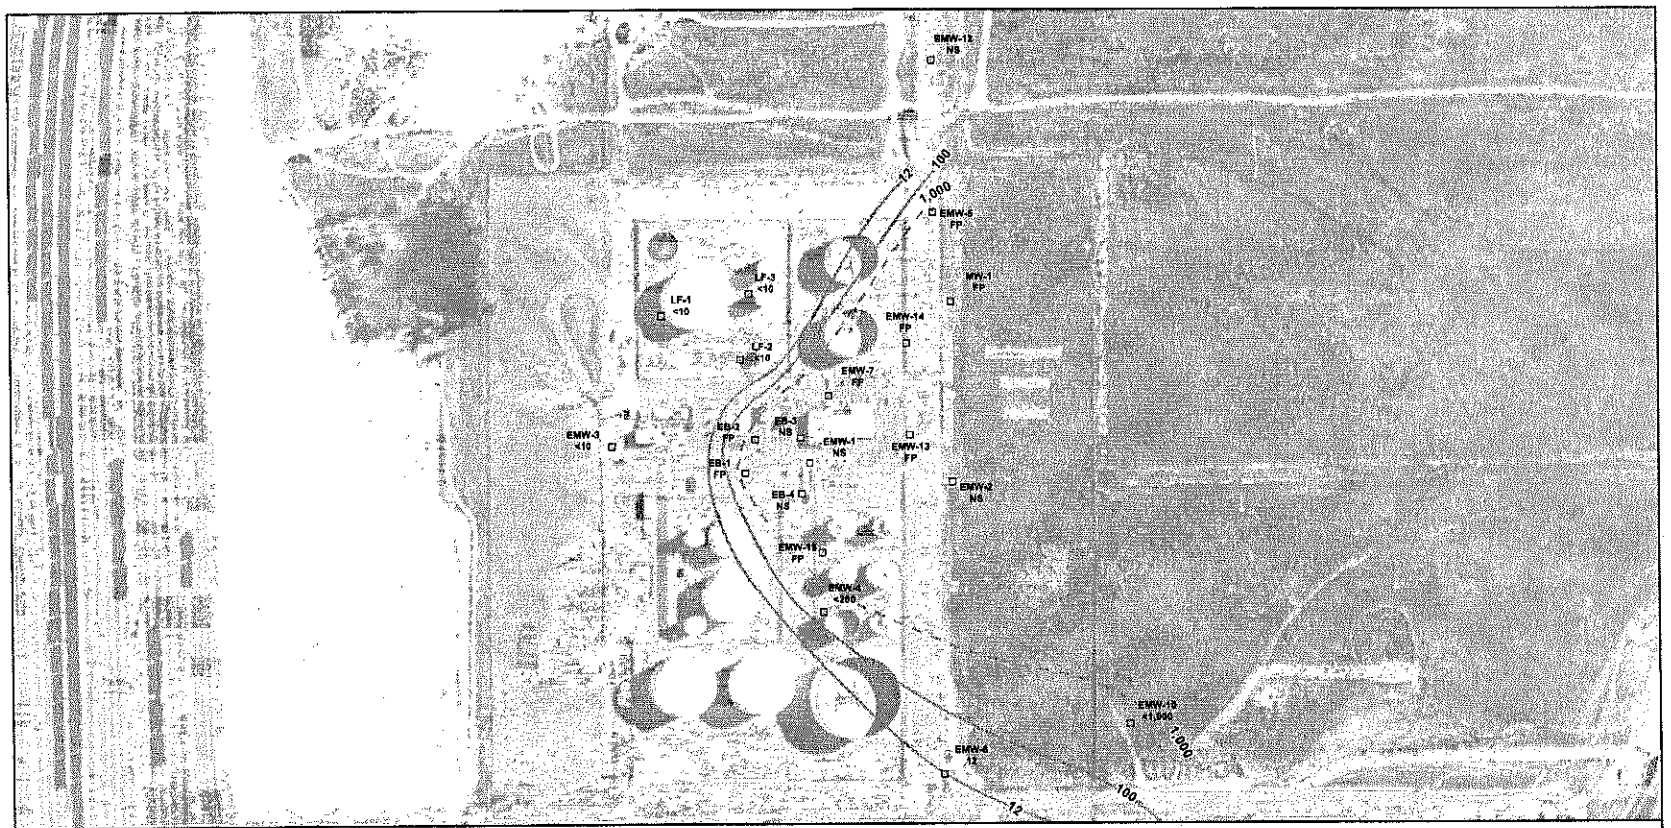
Figure 3-6
TBA Distribution
Perching Silt Unit
Third Quarter 2007

TBA was reported only in EMW-6 at 12 µg/L this quarter (Figure 3-6). This is the first time TBA has been reported in EMW-6 since December 2005 (16 µg/L).

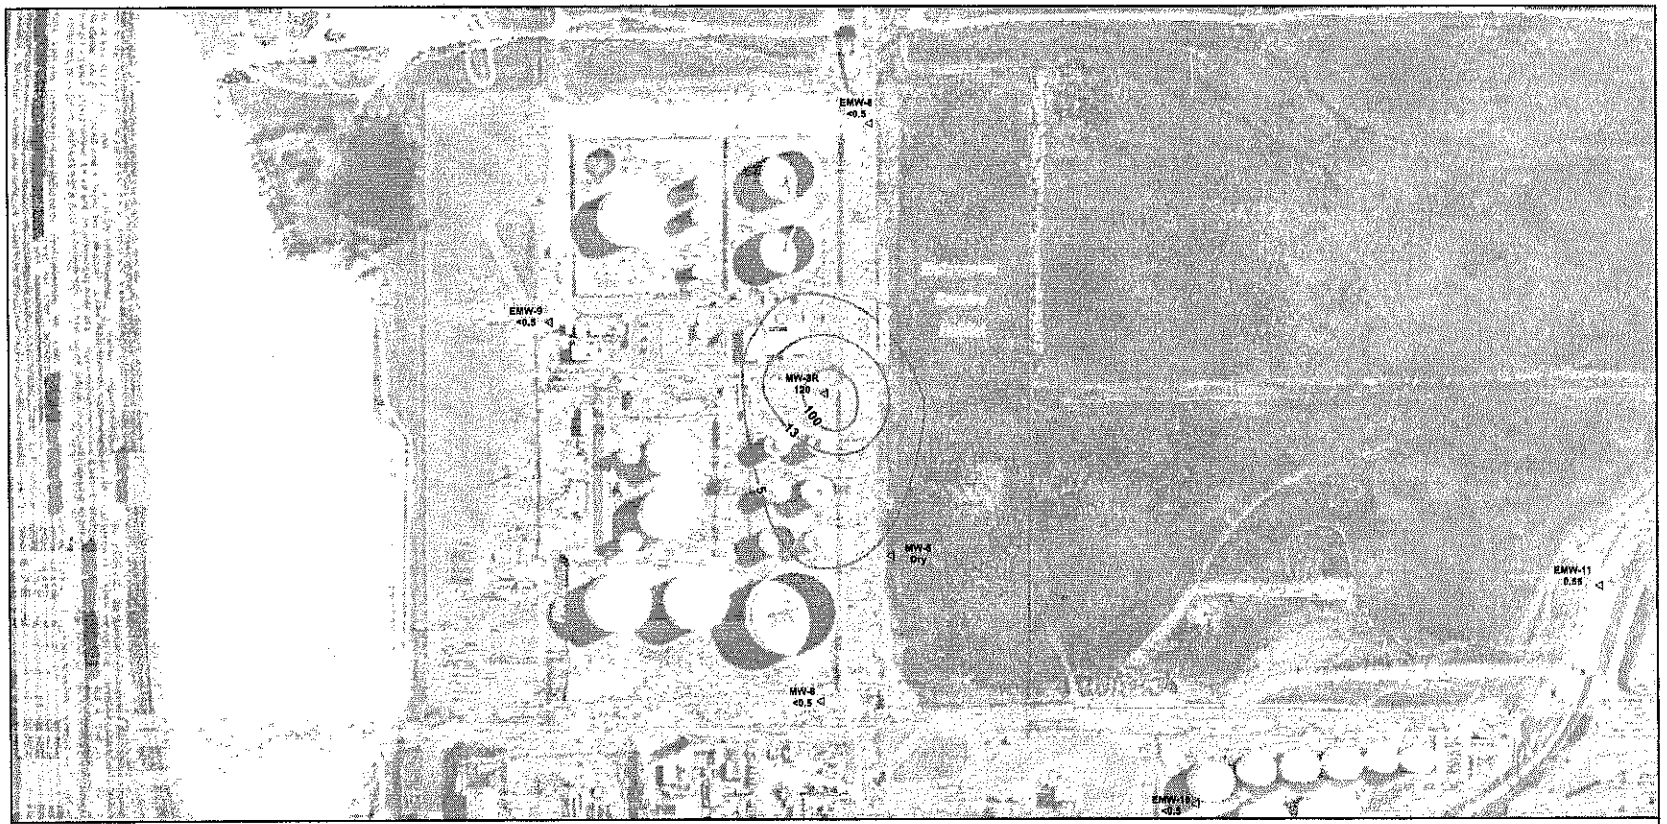
Figure 3-8
MTBE Distribution
Regional Water Table Aquifer
Third Quarter 2007

MTBE was detected in only two wells this quarter: MW-3R at a concentration of 120 µg/L and EMW-11 at a concentration of 0.55 µg/L (Figure 3-8). MTBE was not detected above reporting limits in four wells (EMW-8, EMW-9, EMW-16, and MW-8) this quarter.
